Data Set 1

House Structures

Note: Every house structure has been redrawn by the author from the original reports.

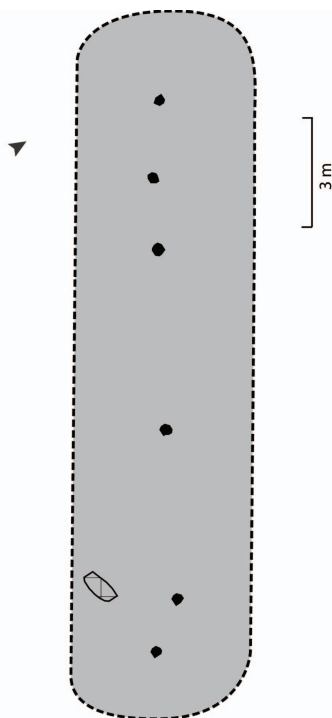
Farmstead	Structure no.	Cadastral/Holding no.	Municipality
Arctanderfjordet	1	21	Farsund
Type	Size	Gable	Exterior construction
Two-aisled	15 m in length	N/A	N/A
Orientation	Period	Uncalibrated BP	Reference
NW-SE	LN I-II	3605 ± 70	Grimsrud 1999, Hauge 2007, Valum 2011

Comments: The two two-aisled longhouses were first interpreted as a three-aisled longhouse but later reinterpreted by Hauge (2007) as two separate houses. The houses contained flint debris, ceramic sherds, burnt bone, and a Vestland adze.

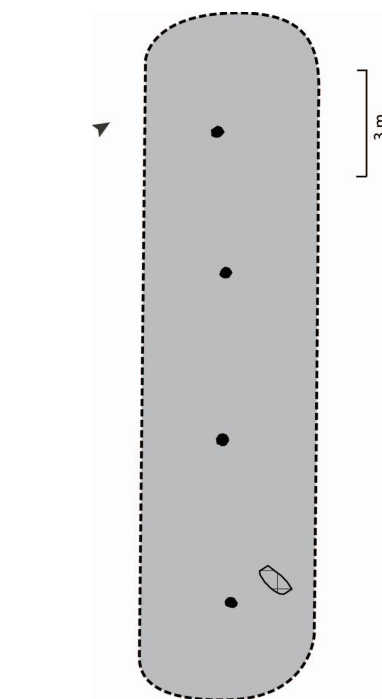
Farmstead	Structure no.	Cadastral/Holding no.	Municipality
Arctanderfjordet	2	21	Farsund
Type	Size	Gable	Exterior construction
Two-aisled	13 m in length	N/A	N/A
Orientation	Period	Uncalibrated BP	Reference
NW-SE	LN II - EBA I	3460 ± 70	Grimsrud 1999, Hauge 2007, Valum 2011

Comments: The two two-aisled longhouses were first interpreted as a three-aisled longhouse but later reinterpreted by Hauge (2007) as two separate houses. The houses contained flint debris, ceramic sherds, burnt bone, and a Vestland adze.

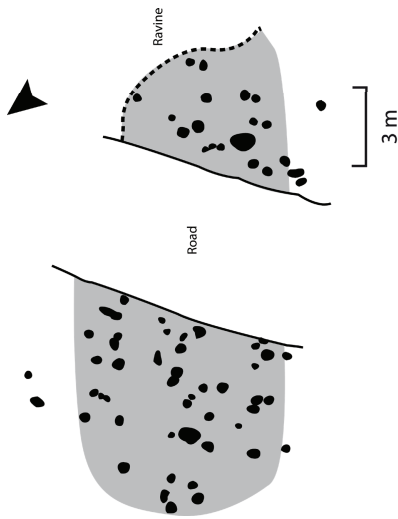
Farmstead	Structure no.	Cadastral/Holding no.	Municipality
Hellvik	N/A	60/13	Eigersund
Type	Size	Gable	Exterior construction
Two-aisled	15-16 m length	N/A	N/A
Orientation	Period	Uncalibrated BP	Reference
NW-SE	EBA I	3290 ± 40	Zinsli 2009

Comments: Two flint scrapers, two drills, one arrowhead, burnt bone, and ceramics were uncovered.

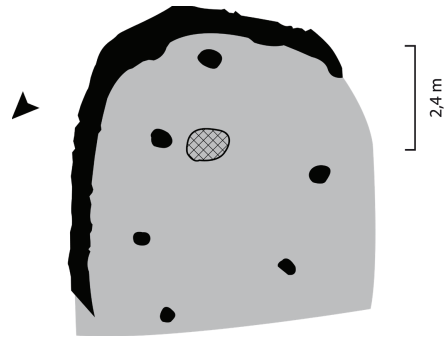
Farmstead	Structure no.	Cadastral/Holding no.	Municipality
Nordre Tengesdal	1	81/4	Bjerkreim
Type	Size	Gable	Exterior construction
Three-aisled	4+ x 6.9	Curved	Planked-built/Trench
Orientation	Period	Uncalibrated BP	Reference
NW-SE	EBA II-III	3010 ± 30	Reiersen 2015

Comments: Contained a hearth and ceramic sherds

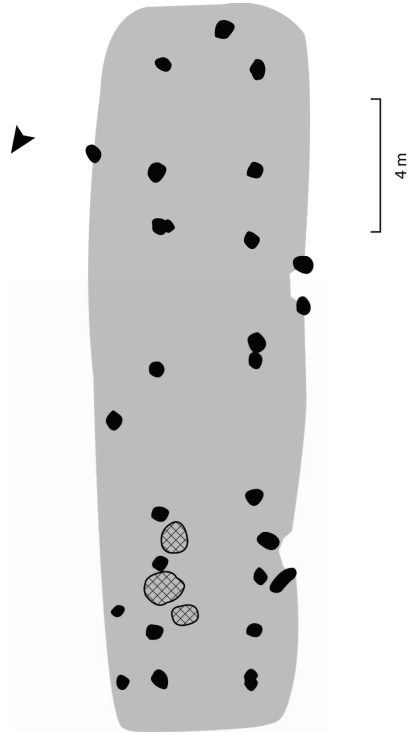
Farmstead	Structure no.	Cadastral/Holding no.	Municipality
Nordre Tengesdal	3	81/4	Bjerkreim
Type	Size	Gable	Exterior construction
Three-aisled	c. 20 x 5,7	N/A	Bole walls?
Orientation	Period	Uncalibrated BP	Reference
NW-SE	EBA II	3110 ± 30, 3070 ± 30, 3060 ± 30, 3060 ± 30, 3040 ± 30	Reiersen 2015

Comments: The house contained a hearth, ceramics, a flint scraper, and two cooking pits. Outside there was another cooking pit with a date to EBA II.

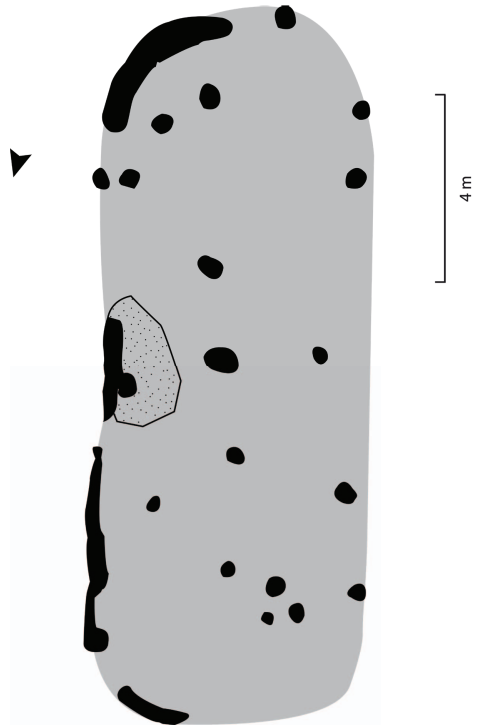
Farmstead	Structure no.	Cadastral/Holding no.	Municipality
Nordre Tengesdal	4	81/4	Bjerkreim
Type	Size	Gable	Exterior construction
Two-aisled	14,9 x 5,8	N/A	Planked-built/Trench
Orientation	Period	Uncalibrated BP	Reference
NW-SE	LN-EBA	no radiometric dating	Reiersen 2015

Comments: None

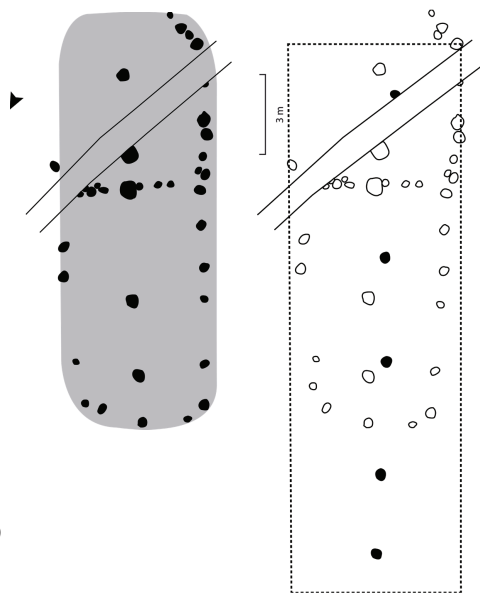
Farmstead	Structure no.	Cadastral/Holding no.	Municipality
Kvia	N/A	19/31	Hå
Type	Size	Gable	Exterior construction
Two-aisled	15 m in length	Curved	Wattle-and-Daub
Orientation	Period	Uncalibrated BP	Reference
NW-SE	LN I - EBA	No radiometric dates	Bjørlo 2011

Comments: The house appears to have two phases, with one having a partition. Pumice, ceramic sherds, and amber were uncovered.

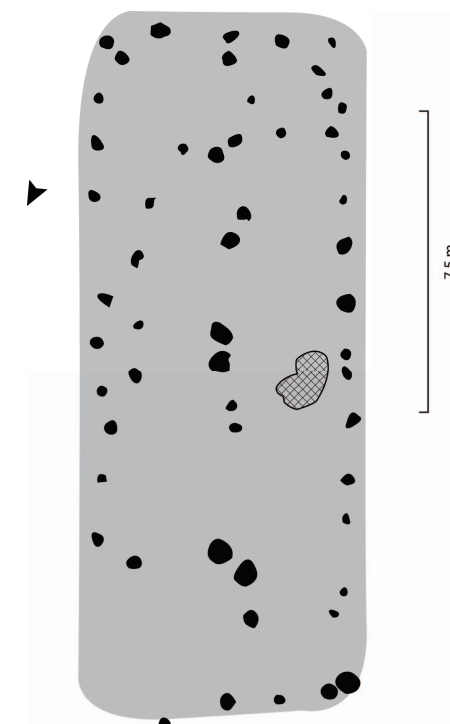
Farmstead	Structure no.	Cadastral/Holding no.	Municipality
Bjørnhaug/Bo	N/A	26	Hå
Type	Size	Gable	Exterior construction
Two-aisled	16.8 x 6.3	Straight	Wattle-and-Daub
Orientation	Period	Uncalibrated BP	Reference
NW-SE	EBA I	3220 ± 30, 3380 ± 30, 3240 ± 30	Fred and Westling 2014, Fyllingen 2015a

Comments: The house contained a heart, ceramics, burnt bone, and scrapers. Flakes from daggers were uncovered nearby.

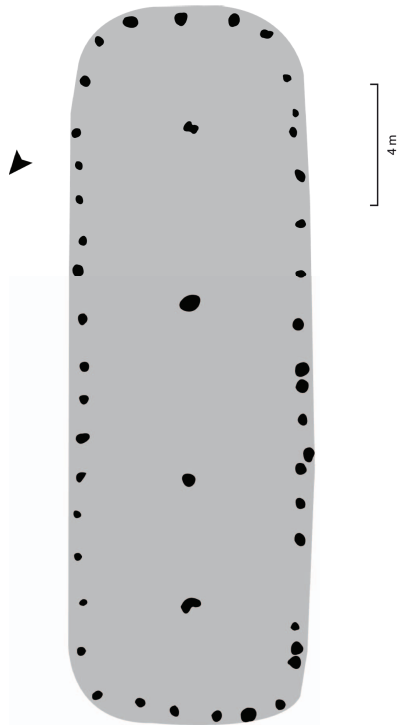
Farmstead	Structure no.	Cadastral/Holding no.	Municipality
Norheim (Wåle)	1	19/11	Time
Type	Size	Gable	Exterior construction
Two-aisled	23 x 7.2	Straight	Wattle-and-Daub
Orientation	Period	Uncalibrated BP	Reference
NW-WSE	LN II - EBA I	3455 ± 50, 3435 ± 65, 3335 ± 50	Soltveit <i>et al.</i> 2007

Comments: None

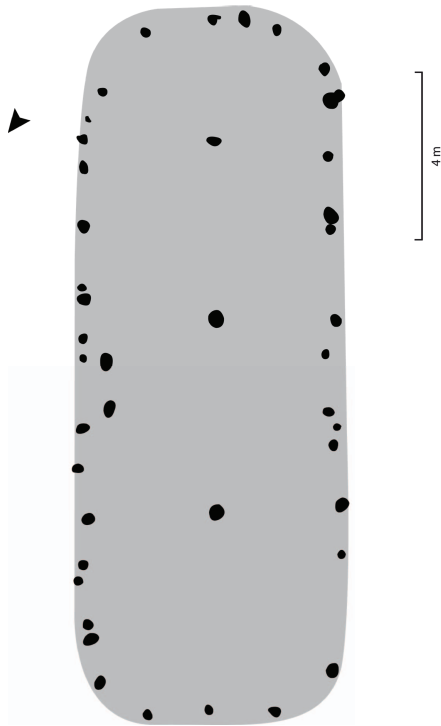
Farmstead	Structure no.	Cadastral/Holding no.	Municipality
Norheim (Wåle)	2	19/11	Time
Type	Size	Gable	Exterior construction
Two-aisled	16.5 x 6	Curved	Wattle-and-Daub
Orientation	Period	Uncalibrated BP	Reference
NW-WSE	LN II	3555 ± 65, 3545 ± 70, 3495 ± 50, 3475 ± 50	Soltveit <i>et al.</i> 2007

Comments: Appears to have two entrances.

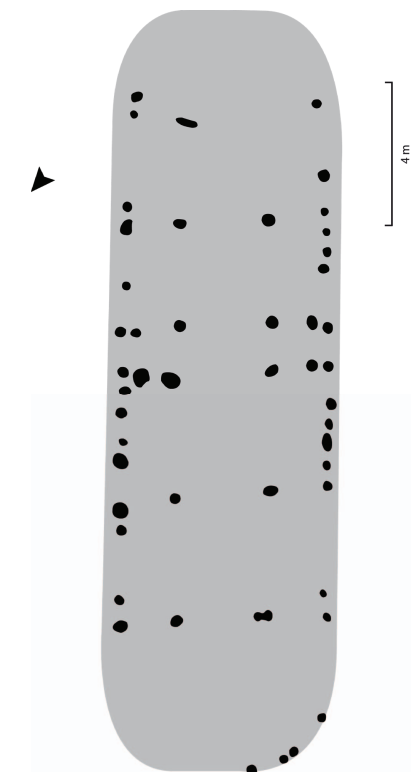
Farmstead	Structure no.	Cadastral/Holding no.	Municipality
Norheim (Wåle)	3	19/11	Time
Type	Size	Gable	Exterior construction
Three-aisled	21-23 x 5.5	Curved	Wattle-and-Daub
Orientation	Period	Uncalibrated BP	Reference
NW-SE	LN II - EBA I	3390 ± 50, 3395 ± 50, 3455 ± 60	Softveit <i>et al.</i> 2007

Comments: None

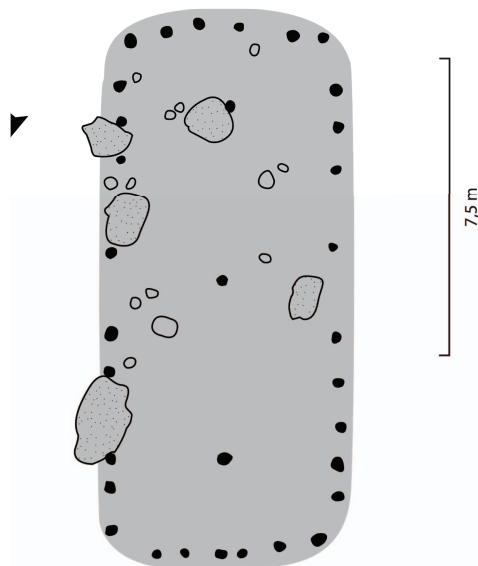
Farmstead	Structure no.	Cadastral/Holding no.	Municipality
Froyland	1	28/1	Time
Type	Size	Gable	Exterior construction
Two-aisled	13.7 x 5.7	Straight	W/A
Orientation	Period	Uncalibrated BP	Reference
NNW-SSE	LN I - LN III	3500 ± 40, 3595 ± 35	Bjorndal 2009

Comments: Fragments of a sickle and two scrapers were uncovered nearby.

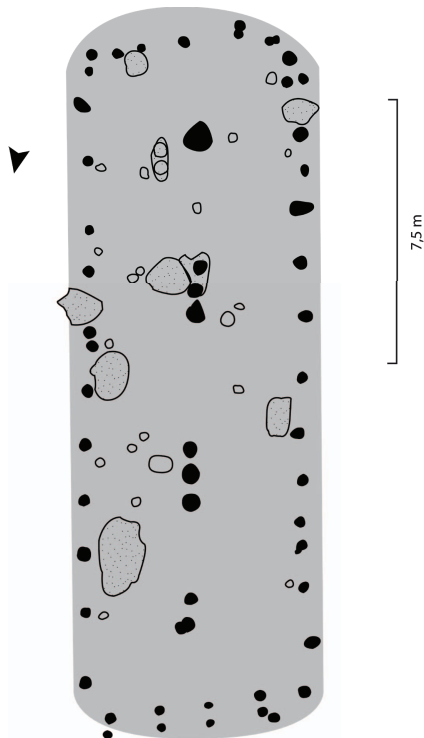
Farmstead	Structure no.	Cadastral/Holding no.	Municipality
Froyland	II	28/1	Time
Type	Size	Gable	Exterior construction
Two-aisled	19.4 x 6.2	Straight	N/A
Orientation	Period	Uncalibrated BP	Reference
NNW-SSE	LN II - EBA I	3565 ± 40, 3465 ± 35, 3440 ± 35, 3410 ± 30	Bjordal 2009

Comments: Ceramic sherds, burnt bone and flint debris were uncovered in the southern part of the house.

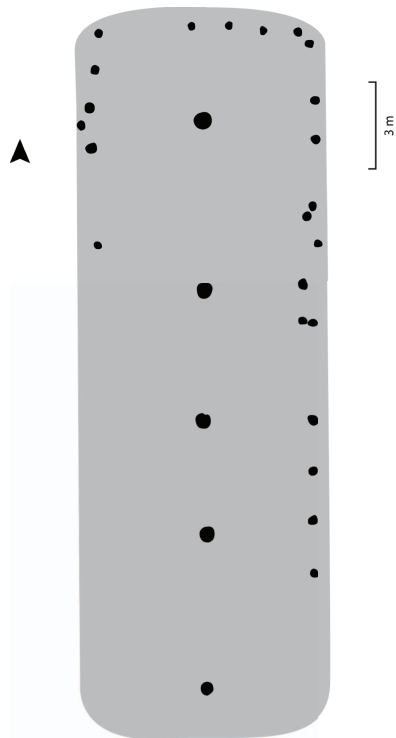
Farmstead	Structure no.	Cadastral/Holding no.	Municipality
Kleppe (Kleppstemmen)	1	1	Klepp
Type	Size	Gable	Exterior construction
Two-aisled	22 m in length	Straight	Wattle-and-Daub or Bole
Orientation	Period	Uncalibrated BP	Reference
N-S	LN - EBA	No radiometric dates	Berge 2007

Comments: None

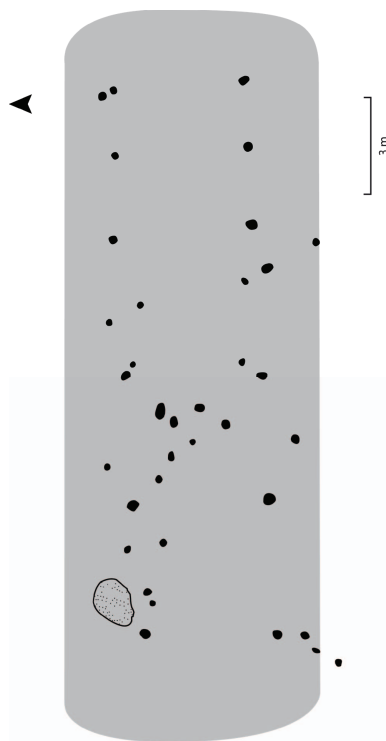
Farmstead	Structure no.	Cadastral/Holding no.	Municipality
Kleppe (Kleppstemmen)	2	1	Klepp
Type	Size	Gable	Exterior construction
Three-aisled	c. 24 x 9	N/A	N/A
Orientation	Period	Uncalibrated BP	Reference
W-E	EBA I	3335 ± 35, 3200 ± 35, 3365 ± 35	Berge 2007

Comments: The largest house in northwestern Scandinavia (216 km²).

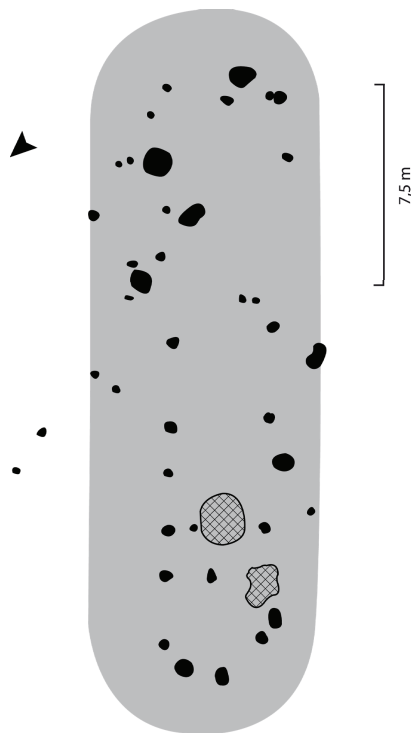
Farmstead	Structure no.	Cadastral/Holding no.	Municipality
Kleppe (Kleppvarden)	1	1	Klepp
Type	Size	Gable	Exterior construction
Three-aisled	28 x 7	N/A	N/A
Orientation	Period	Uncalibrated BP	Reference
NW-SE	EBA III - LBA IV	2840 ± 40, 3040 ± 40	Dahl 2007

Comments: This is the longest house in northwestern Scandinavia. A combination tool in OxCal can be used to tentatively date the house to Early Bronze Age period III.

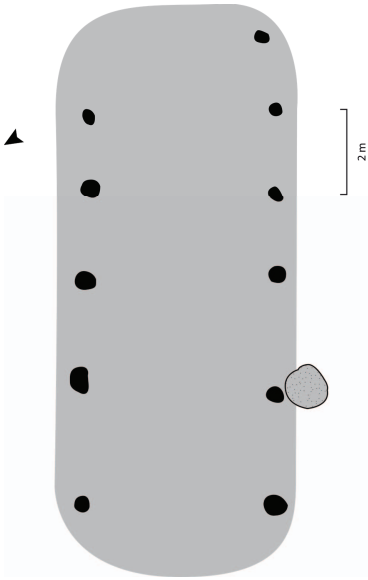
Farmstead	Structure no.	Cadastral/Holding no.	Municipality
Skelane	1	40/246	Sandnes
Type	Size	Gable	Exterior construction
Three-abled	13 x 8	N/A	N/A
Orientation	Period	Uncalibrated BP	Reference
W-E	EBA I - II	3222 ± 54	Hovre 2010

Comments: None

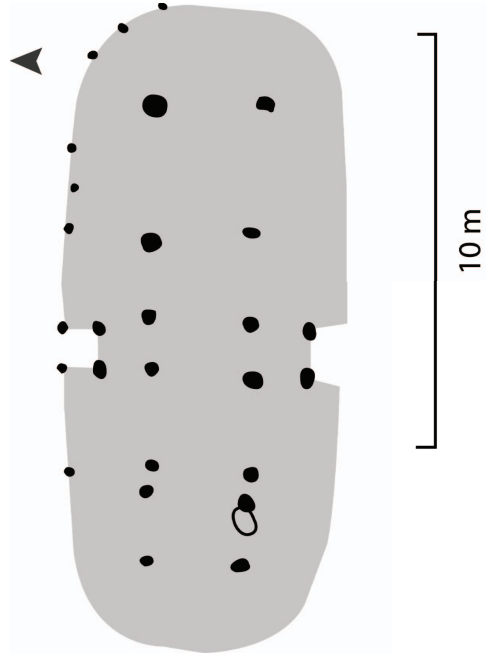
Farmstead	Structure no.	Cadastral/Holding no.	Municipality
Forsandmoen	CCVII	37/5	Forsand
Type	Size	Gable	Exterior construction
Three-abled	15.8 x 6.4	Curved	Wattle-and-Daub
Orientation	Period	Uncalibrated BP	Reference
W-E	EBA III - LBA V	2870 ± 110	Løken 1998

Comments: None

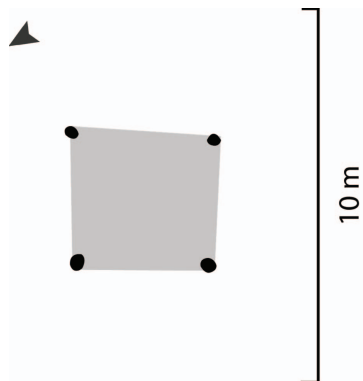
Farmstead	Structure no.	Cadastral/Holding no.	Municipality
Forsandmoen	Fig. 6a	37/5	Forsand
Type	Size	Gable	Exterior construction
Hut	3.8 x 3.5	N/A	N/A
Orientation	Period	Uncalibrated BP	Reference
N/A	EBA II - LBA IV	3030 ± 110	Løken 1998

Comments: None

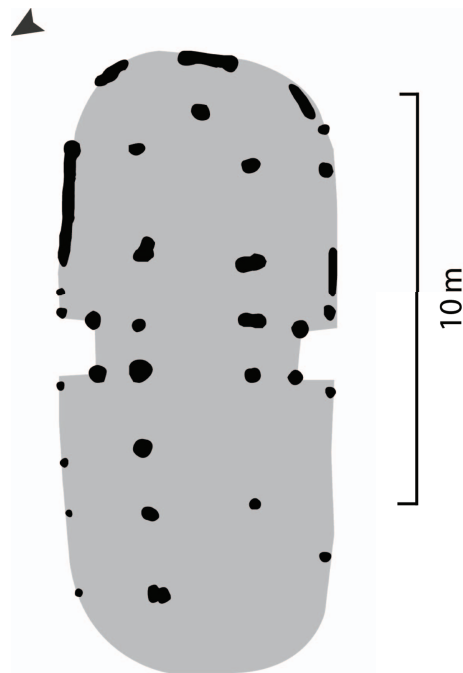
Farmstead	Structure no.	Cadastral/Holding no.	Municipality
Forsandmoen	XLV	37/5	Forsand
Type	Size	Gable	Exterior construction
Three-aisled	c. 15 x 6 m	Curved	Wattle-and-Daub or Bole
Orientation	Period	Uncalibrated BP	Reference
WNE-SES	EBA I - EBA III	3140 ± 90	Løken 1998

Comments: None

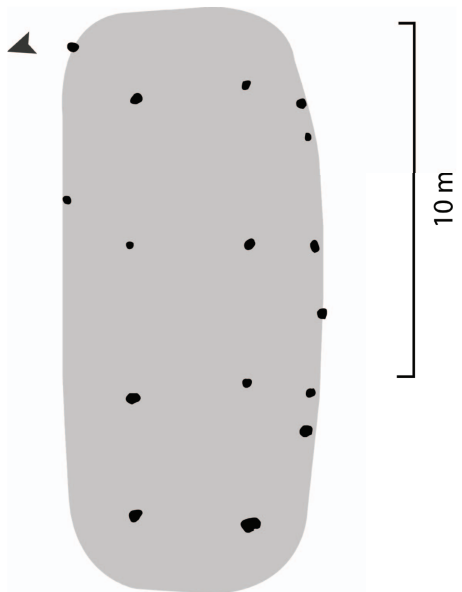
Farmstead	Structure no.	Cadastral/Holding no.	Municipality
Forsandmoen	XC	37/5	Forsand
Type	Size	Gable	Exterior construction
Three-aisled	c.15 x 6 m	Curved	Wattle-and-Daub
Orientation	Period	Uncalibrated BP	Reference
WNW-SES	EBA II	3155 ± 60, 3150 ± 60, 3145 ± 55, 3115 ± 80, 2930 ± 70	Løken 1998

Comments: None

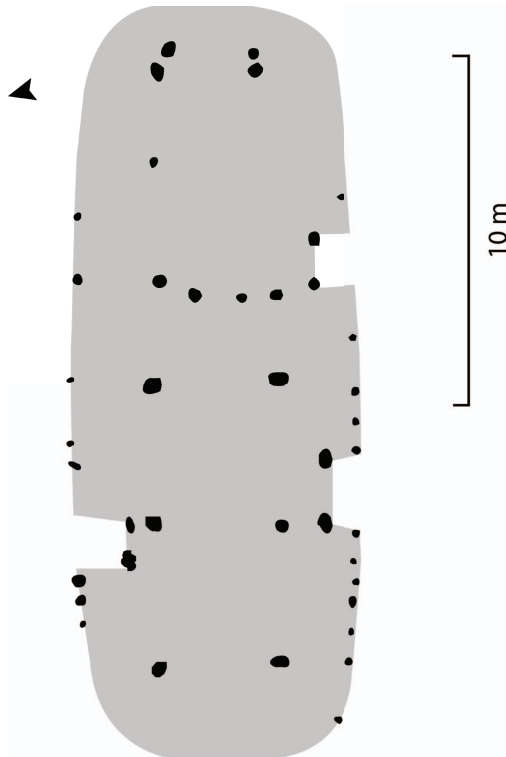
Farmstead	Structure no.	Cadastral/Holding no.	Municipality
Forsandmoen	XXXII B	37/5	Forsand
Type	Size	Gable	Exterior construction
Three-aisled	22-23 m long, 8 m wide	Curved	Wattle-and-Daub
Orientation	Period	Uncalibrated BP	Reference
WNW-SES	EBA II	3275 ± 65, 3245 ± 60, 3220 ± 65, 3185 ± 65, 3210 ± 45, 3175 ± 50, 3185 ± 45, 3150 ± 65, 3135 ± 65, 3125 ± 65, 3070 ± 75, 3080 ± 50, 3040 ± 65, 2990 ± 70, 3015 ± 65	Løken 1998

Comments: None

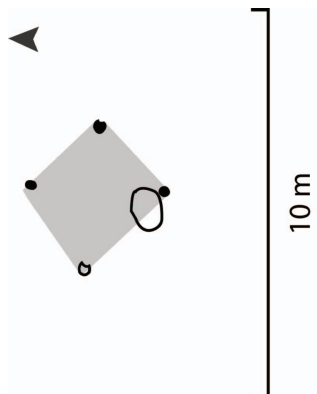
Farmstead	Structure no.	Cadastral/Holding no.	Municipality
Forsandmoen	CCXIII	37/5	Forsand
Type	Size	Gable	Exterior construction
Hut	3.8 x 3.5	N/A	N/A
Orientation	Period	Uncalibrated BP	Reference
N/A	EBA III - LBA V	No radiometric dates	Løken 1998

Comments: The hut appears to be stratigraphically and spatially connected with CCXII, which has been radiocarbon dated to Period III - V.

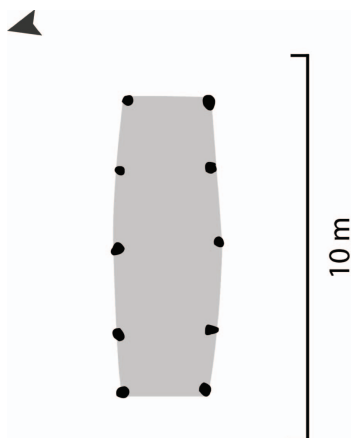
Farmstead	Structure no.	Cadastral/Holding no.	Municipality
Forsandmoen	fig. 7d	37/5	Forsand
Type	Size	Gable	Exterior construction
Three-aisled	10.5 x 3.2	N/A	N/A
Orientation	Period	Uncalibrated BP	Reference
WNE-SES	EBA?	No radiometric dates	Løken 1998

Comments: None

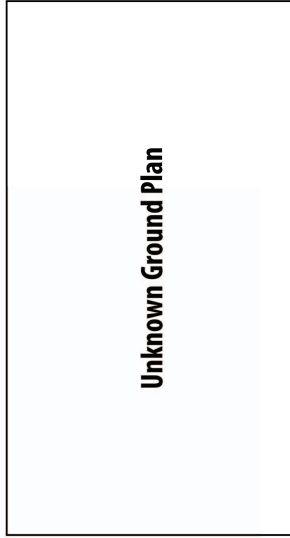
Farmstead	Structure no.	Cadastral/Holding no.	Municipality
Berge	N/A	N/A	Forsand
Type	Size	Gable	Exterior construction
Three-aisled	N/A	N/A	N/A
Orientation	Period	Uncalibrated BP	Reference
N/A	EBA	N/A	http://www.norark.no/prosjekter/bergevik/4783/

Comments: The excavation report was not available at the time of writing.

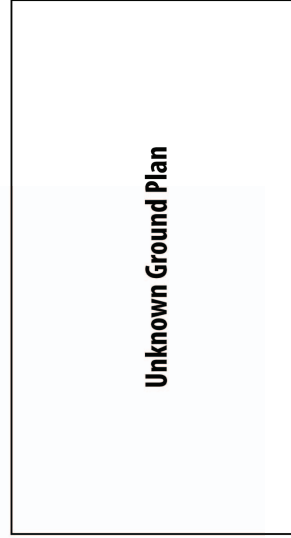
Farmstead	Structure no.	Cadastral/Holding no.	Municipality
Berge	N/A	N/A	Forsand
Type	Size	Gable	Exterior construction
Two-aisled	N/A	N/A	N/A
Orientation	Period	Uncalibrated BP	Reference
N/A	LN - EBA	N/A	http://www.norark.no/prosjekter/bergevik/4783/

Comments: The excavation report was not available at the time of writing.

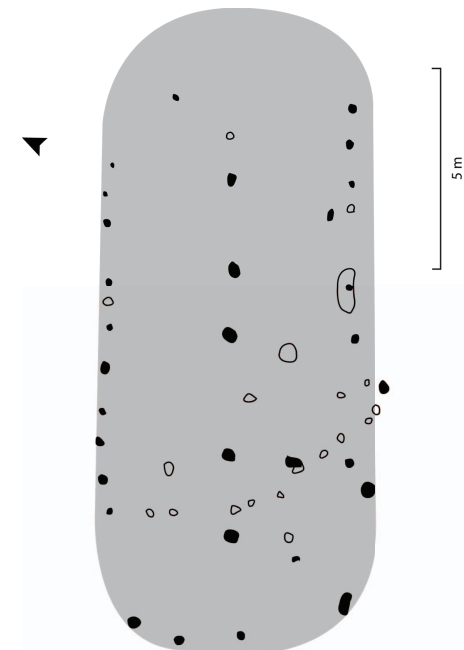
Farmstead	Structure no.	Cadastral/Holding no.	Municipality
Reyneberg	B	35	Sola
Type	Size	Gable	Exterior construction
Two-aisled	14 x 6.3	Straight	Wattle-and-Daub
Orientation	Period	Uncalibrated BP	Reference
SW-NE	EBA I	3320 ± 50, 3215 ± 55, 3505 ± 55, 3405 ± 65	Soltveit <i>et al.</i> 2007

Comments: Also referred to as Kidlingberget.

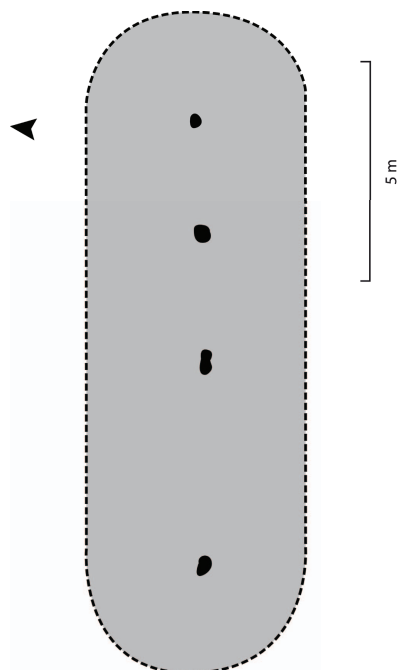
Farmstead	Structure no.	Cadastral/Holding no.	Municipality
Reyneberg	C	35	Sola
Type	Size	Gable	Exterior construction
Two-aisled	N/A	N/A	N/A
Orientation	Period	Uncalibrated BP	Reference
SW-NE	LN - EBA2	No radiometric dates	Soltveit <i>et al.</i> 2007

Comments: None

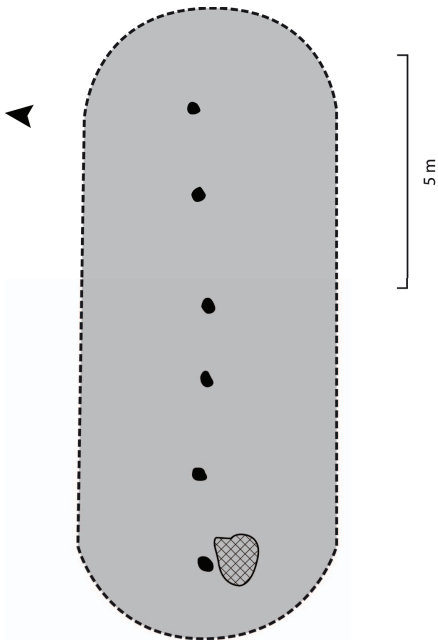
Farmstead	Structure no.	Cadastral/Holding no.	Municipality
Røyneberg	D	35	Sola
Type	Size	Gable	Exterior construction
Two-aisled	N/A	N/A	N/A
Orientation	Period	Uncalibrated BP	Reference

SW-NE LN - EBA? No radiometric dates *Soltvedt et al. 2007*

Comments: None

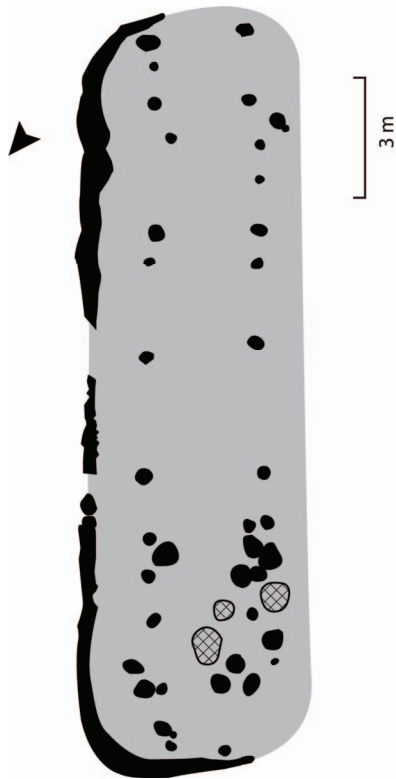
Farmstead	Structure no.	Cadastral/Holding no.	Municipality
Tjora	4	10	Sola
Type	Size	Gable	Exterior construction
Three-aisled	20.6 x 6.2	Curved	Planked-built/Trench
Orientation	Period	Uncalibrated BP	Reference

NW-SE EBA II - III 2985 ± 40 *Fyllingen 2012*

Comments: The house also has a date to EBA I from a charred cereal. A saddle quern was uncovered adjacent to the house.

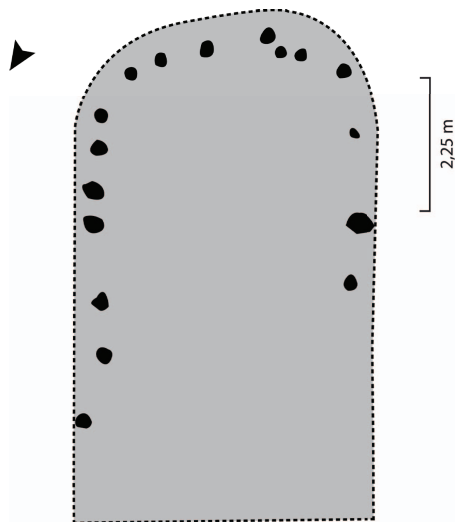
Farmstead	Structure no.	Cadastral/Holding no.	Municipality
Tjøra	6	10	Sola
Type	Size	Gable	Exterior construction
Two-aisled	11+ x 4.3	Curved	Wattle-and-Daub?
Orientation	Period	Uncalibrated BP	Reference
NW-SE	LN - EBA	No radiometric dates	Fyllingen 2012

Comments: None

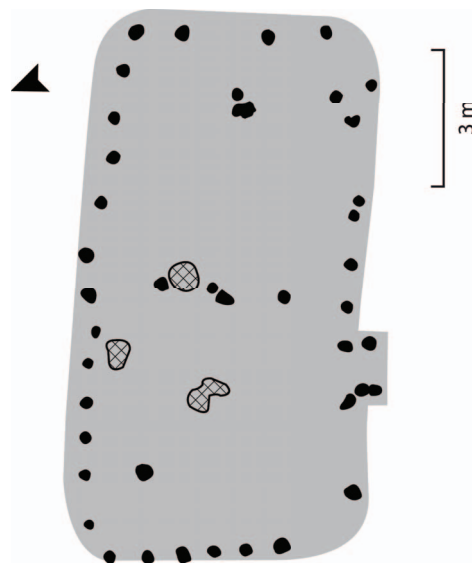
Farmstead	Structure no.	Cadastral/Holding no.	Municipality
Tjøra	7	10	Sola
Type	Size	Gable	Exterior construction
Two-aisled	11,8 x 5,5	Straight	Wattle-and-Daub
Orientation	Period	Uncalibrated BP	Reference
WNW-ESE	LN II - EBA I	3325 ± 35, 3460 ± 30	Fyllingen 2012

Comments: Possibly a hybrid construction with a two-aisled and a three-aisled part. An amber pearl, burnt bone, flint debris, and ceramic sherds were uncovered in the house.

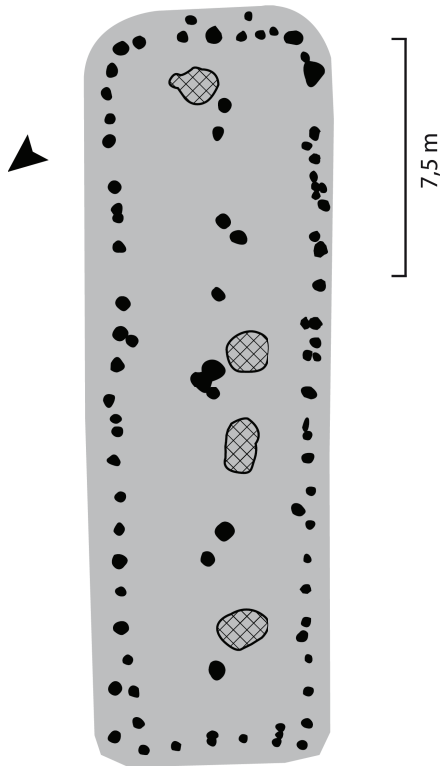
Farmstead	Structure no.	Cadastral/Holding no.	Municipality
Tjora	9	10	Sola
Type	Size	Gable	Exterior construction
Two-aisled	22,3 x 6	Straight	Wattle-and-Daub
Orientation	Period	Uncalibrated BP	Reference
NW-SE	LN II - EBA I	3340 ± 40, 3380 ± 40	Fyllingen 2012

Comments: Numerous flakes from either dagger or axe production. A scraper, burnt bone and pottery sherds were uncovered.

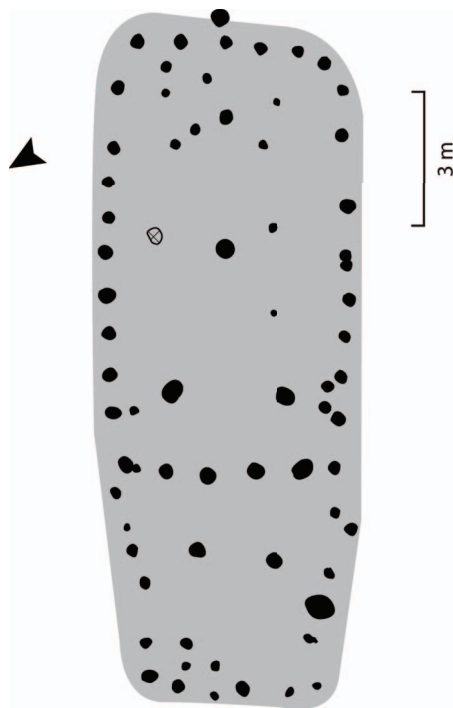
Farmstead	Structure no.	Cadastral/Holding no.	Municipality
Tjora	10	10	Sola
Type	Size	Gable	Exterior construction
Two- and three-aisled (hybrid)	15 x 5,5	Straight	Wattle-and-Daub
Orientation	Period	Uncalibrated BP	Reference
NW-SSE	LN II - EBA I	3365 ± 30	Fyllingen 2012

Comments: A hybrid house construction including a two-aisled and a three-aisled part. The house contained traces of flint, burnt bone, and pottery sherds.

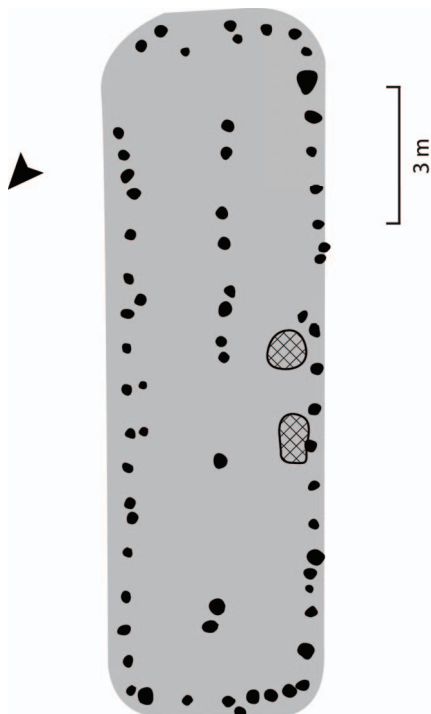
Farmstead	Structure no.	Cadastral/Holding no.	Municipality
Tjøra	11	10	Sola
Type	Size	Gable	Exterior construction
Two-aisled	22.7 x 6.3	Straight	Wattle-and-Daub
Orientation	Period	Uncalibrated BP	Reference
NNV-SSe	EBA I	3310 ± 40, 3345 ± 40	Fyllingen 2012

Comments: The house contained flint debris, two scrapers, a piece from a sickle, a piece from a spearhead, burnt bone, and pottery sherds.

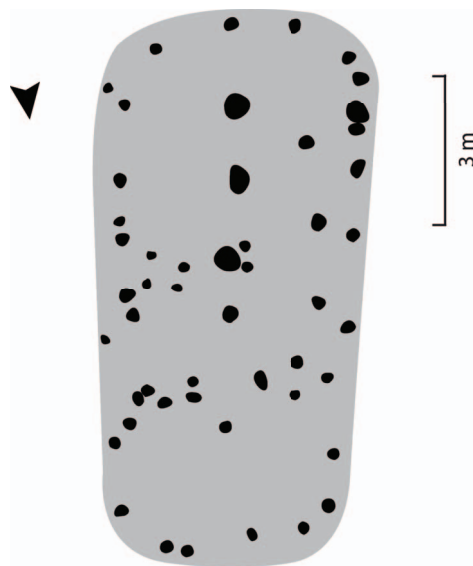
Farmstead	Structure no.	Cadastral/Holding no.	Municipality
Tjøra	12	10	Sola
Type	Size	Gable	Exterior construction
Two-aisled	10.2 x 4.3-4.7	Curved	Wattle-and-Daub
Orientation	Period	Uncalibrated BP	Reference
NNE-SSW	LN III	3525 ± 30, 3470 ± 30	Fyllingen 2012

Comments: Contained pottery sherds

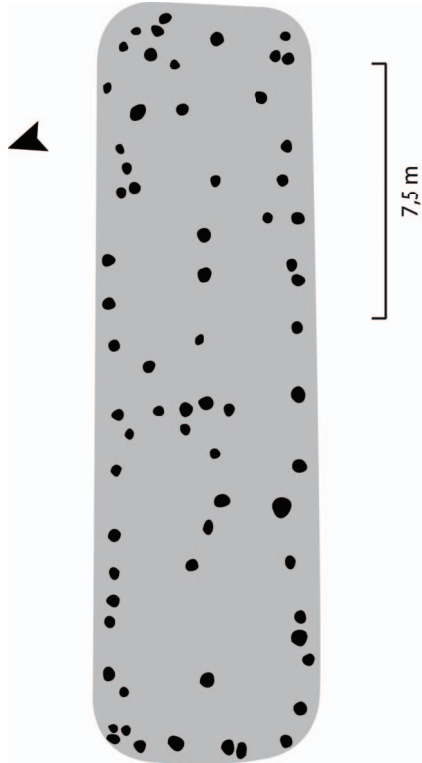
Farmstead	Structure no.	Cadastral/Holding no.	Municipality
Tjora	13	10	Sola
Type	Size	Gable	Exterior construction
Two-aisled	20.8x5.3	Straight	Wattle-and-Daub
Orientation	Period	Uncalibrated BP	Reference
NW-SE	LN I - LN II	3560 ± 30, 3635 ± 30	Fyllingen 2012

Comments: The house contained flint debris, a quartz crystal, pottery sherds, and burnt bone.

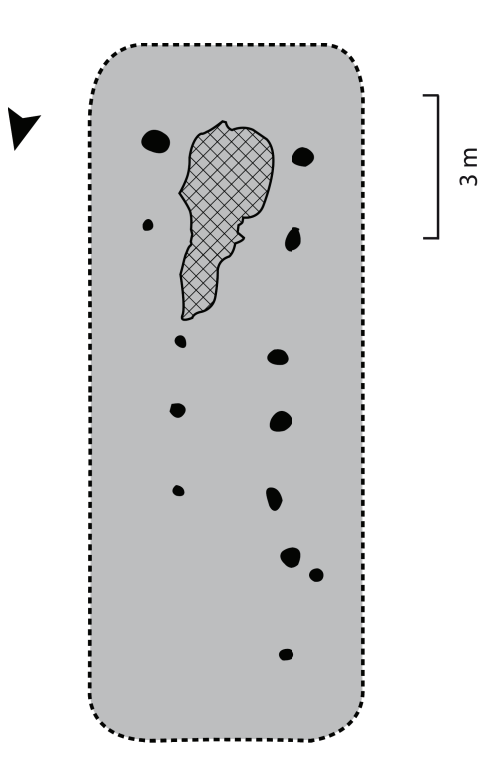
Farmstead	Structure no.	Cadastral/Holding no.	Municipality
Tjora	14	10	Sola
Type	Size	Gable	Exterior construction
Three-aisled	N/A	N/A	N/A
Orientation	Period	Uncalibrated BP	Reference
NNW-SSE	BA	No radiometric dates	Fyllingen 2012

Comments: The house contained a cooking pit, burnt bone, flint, and pottery sherds.

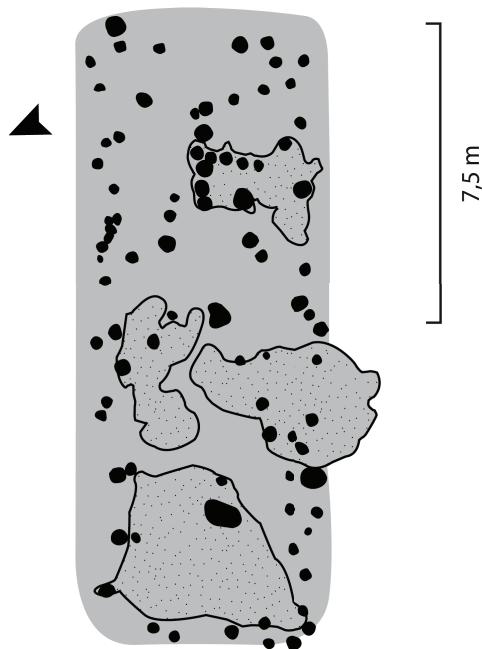
Farmstead	Structure no.	Cadastral/Holding no.	Municipality
Tjora	15	10	Sola
Type	Size	Gable	Exterior construction
Two-aisled	14.6x4.8	Straight	Wattle-and-Daub
Orientation	Period	Uncalibrated BP	Reference
NW-SE	LN II	3545 ± 30, 3530 ± 40	Fyllingen 2012

Comments: The house had traces of a floor, and contained flakes from daggers and/or axe production. Other finds included two scrapers, a flint arrowhead, pottery sherds, and burnt bone.

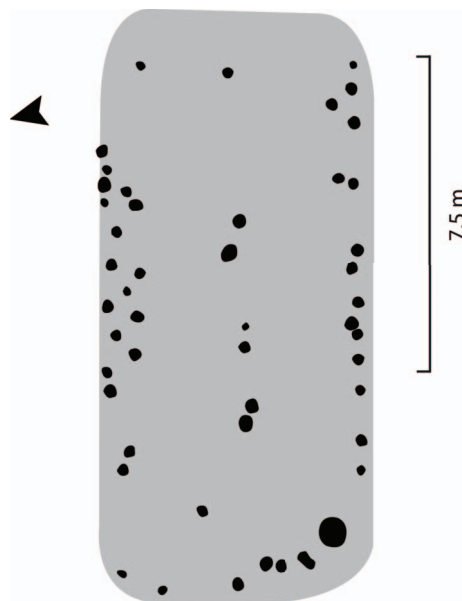
Farmstead	Structure no.	Cadastral/Holding no.	Municipality
Tjora	16	10	Sola
Type	Size	Gable	Exterior construction
Two-aisled	12.5x5.8	Straight	Wattle-and-Daub
Orientation	Period	Uncalibrated BP	Reference
NW-SE	LN - EBA	No radiometric dates	Fyllingen 2012

Comments: The house contained traces of flint and pottery sherds.

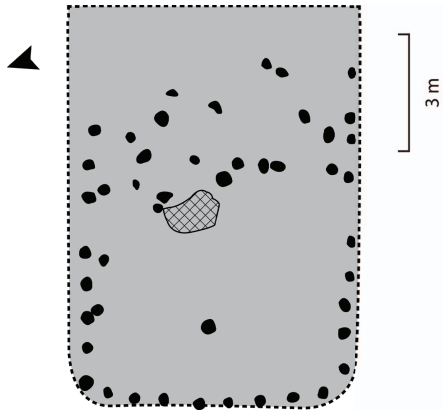
Farmstead	Structure no.	Cadastral/Holding no.	Municipality
Tjøra	17	10	Sola
Type	Size	Gable	Exterior construction
Two-aisled	12+ x 6.5	Straight	Wattle-and-Daub
Orientation	Period	Uncalibrated BP	Reference
NNW-ESE	EBA I	3305 ± 35	Fyllingen 2012

Comments: None

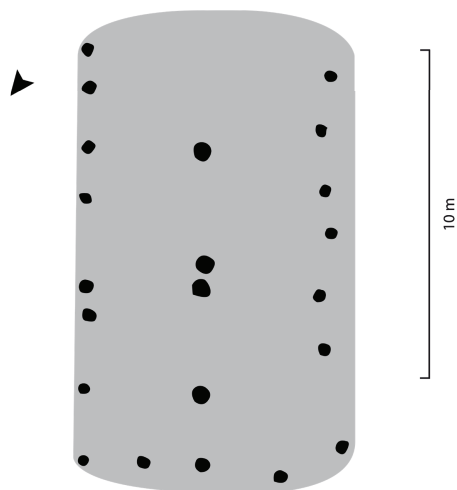
Farmstead	Structure no.	Cadastral/Holding no.	Municipality
Sammenrågen	N/A	N/A	Sola
Type	Size	Gable	Exterior construction
Two-aisled	11 x 6	N/A	N/A
Orientation	Period	Uncalibrated BP	Reference
NW-SE	LN - EBA	N/A	Eilertsen 2016

Comments: The excavation report was not available at the time of writing. The house may have contained a hearth, and there were pottery sherds, and traces of a floor (sunken areas).

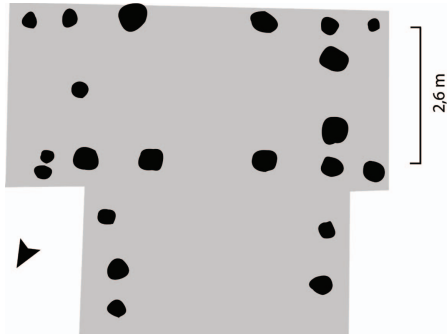
Farmstead	Structure no.	Cadastral/Holding no.	Municipality
Myklebust	VII	3	Sola
Type	Size	Gable	Exterior construction
Three-aisled	6 x 7	N/A	Bole walls?
Orientation	Period	Uncalibrated BP	Reference
NW-SE	LN II	3375 ± 45, 3590 ± 35, 3490 ± 40	Dahl 2014

Comments: None

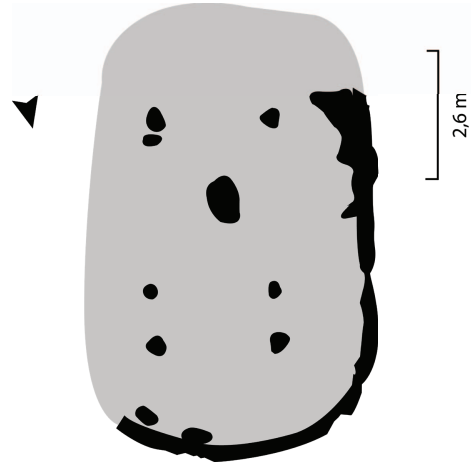
Farmstead	Structure no.	Cadastral/Holding no.	Municipality
Myklebust	VIII	3	Sola
Type	Size	Gable	Exterior construction
Three-aisled	9.3 x 6.5	Curved	Planked-built/trench
Orientation	Period	Uncalibrated BP	Reference
NNE-SSW	EBA II	3160 ± 35, 3140 ± 30, 3075 ± 30	Dahl 2014

Comments: The three-aisled house contained a hearth, pottery sherds, and a grinding stone.

Comments: Similar construction as Houses VIII, XV, XVI, and XVIII at Myklebust with a large hearth and air-vents. The hearth was covered by a stone slab. Burnt bone and charred cereal were uncovered in the air-vents. A small stone was uncovered at the end of one of the air-vents, which use may have been to regulate air.

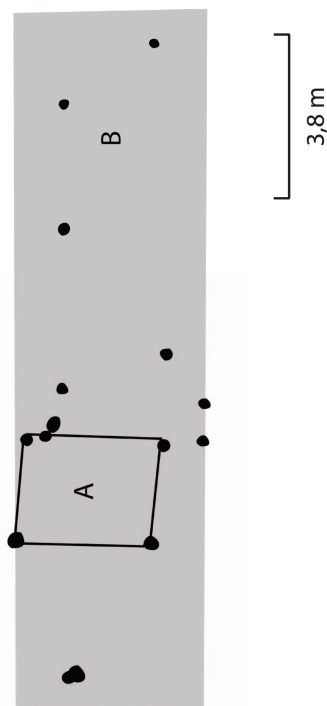
Farmstead	Structure no.	Cadastral/Holding no.	Municipality
Myklebust	X	3	Sola
Type	Size	Gable	Exterior construction
Three-aisled	19+ x 5.5	N/A	N/A
Orientation	Period	Uncalibrated BP	Reference
NNW-SSE	EBA III – LBA IV	2914 ± 31, 2899 ± 30	Dahl 2014

Comments: A dagger (B4671) and a scraper (B4662) were uncovered nearby.

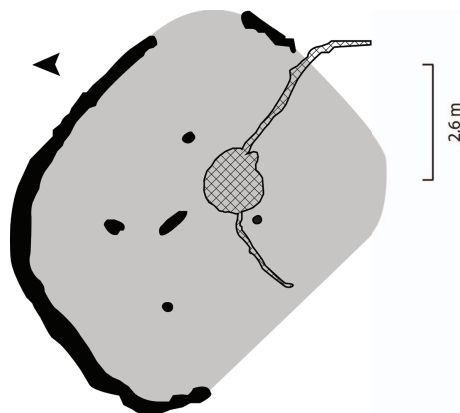
Farmstead	Structure no.	Cadastral/Holding no.	Municipality
Myklebust	XIV	3	Sola
Type	Size	Gable	Exterior construction
Hut	7.9 x 6.2	Curved	Planked-built/trench
Orientation	Period	Uncalibrated BP	Reference
NW-SE	EBA II – EBA III	3170 ± 35, 2995 ± 30, 3095 ± 30	Dahl 2014

Comments: The hut has a big hearth with air vents. The hearth contained burnt bone and flint debris.

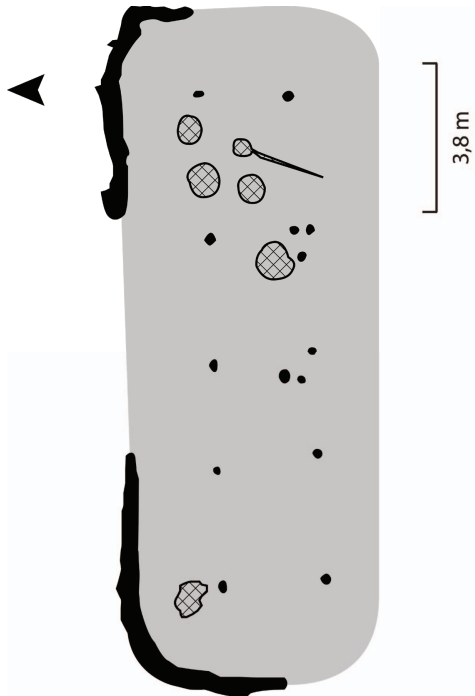
Farmstead	Structure no.	Cadastral/Holding no.	Municipality
Myklebust	XV	3	Sola
Type	Size	Gable	Exterior construction
Three-abled	18 x 7.1	Curved	Planked-built/Trench
Orientation	Period	Uncalibrated BP	Reference
NW-SE	EBA II - EBA III	3100 ± 40, 3085 ± 35, 3010 ± 30	Dahl 2014

Comments: The house contained a hearth with 'air vent', flint debris, burnt bone, and pottery sherds. At the southern entrance two quern stones were uncovered.

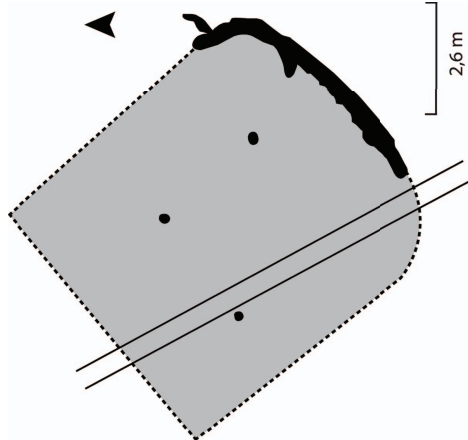
Farmstead	Structure no.	Cadastral/Holding no.	Municipality
Myklebust	XVI	3	Sola
Type	Size	Gable	Exterior construction
Hut?	7.37 x 4.55	Curved	Planked-built/Trench
Orientation	Period	Uncalibrated BP	Reference
NW-SE	EBA II	No radiometric dates	Dahl 2014

Comments: Based on house typology and stratigraphical relation with neighbouring houses the hut can be tentatively dated to EBA II.

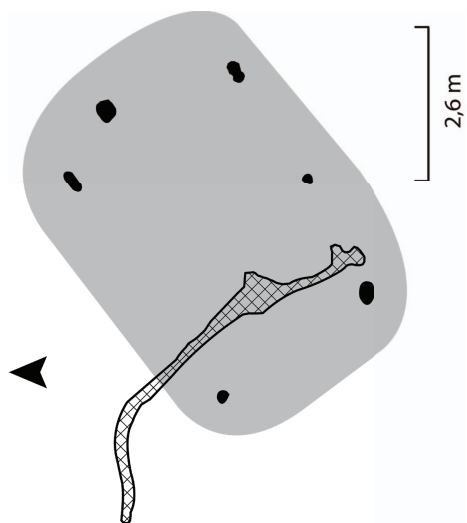
Farmstead	Structure no.	Cadastral/Holding no.	Municipality
Myklebust	XVIII	3	Sola
Type	Size	Gable	Exterior construction
Hut	8.5+x7?	N/A	N/A
Orientation	Period	Uncalibrated BP	Reference
SW-NE	EBA I	3240 ± 30, 3250 ± 30, 3280 ± 30	Dahl 2014

Comments: The hut contains a hearth with 'air vents'.

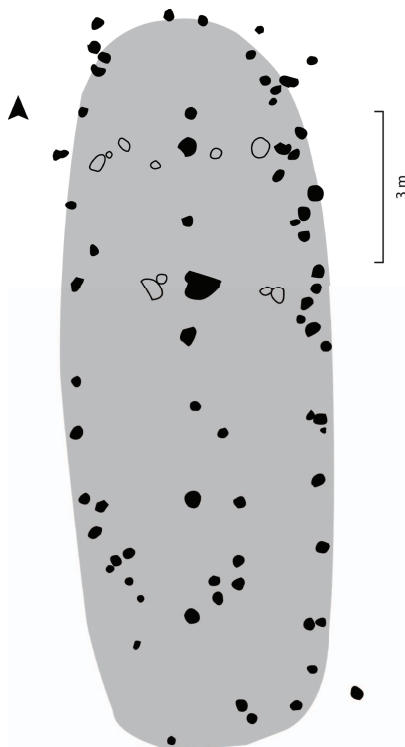
Farmstead	Structure no.	Cadastral/Holding no.	Municipality
Jåsund	1	1	Rogaland
Type	Size	Gable	Exterior construction
Two-aisled	15 x 5,2-5,5	Curved	Wattle-and-Daub or Boie
Orientation	Period	Uncalibrated BP	Reference
NNW-SSE	LN III	3600 ± 40+	Fyllingen 2015b

Comments: The house appears to have two phases (see house no. 2). Ceramic sherds, flint debris, and pumice were uncovered in postholes. Based on radiocarbon dates from two postholes as well as stratigraphy. The curved gable walls may suggest an earlier date than the second phase.

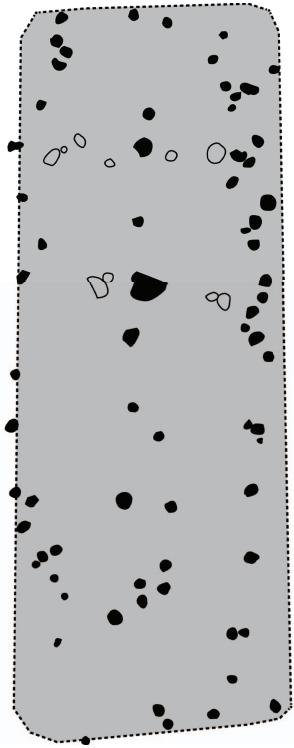
Farmstead	Structure no.	Cadastral/Holding no.	Municipality
Jåsund	2	1	Rogaland
Type	Size	Gable	Exterior construction
Two-aisled?	N/A	Straight	Wattle-and-Daub or Bole
Orientation	Period	Uncalibrated BP	Reference
NNW-SSE	LN II - EBA I	3380 ± 40	Fyllingen 2015b

Comments: A possible second phase of the house. Based on radiocarbon dates from two postholes as well as stratigraphy. The straight gable walls may suggest a later date than the first phase.

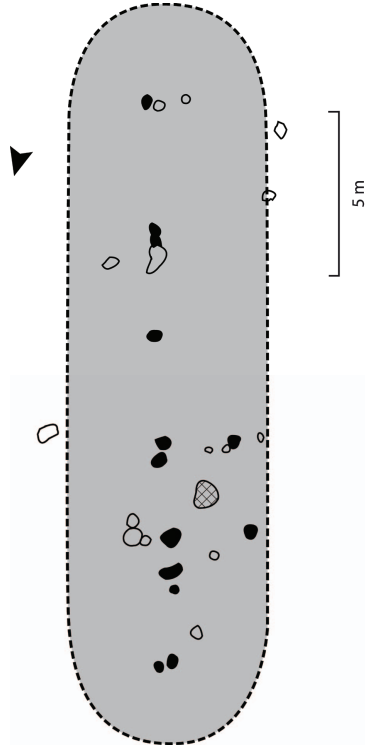
Farmstead	Structure no.	Cadastral/Holding no.	Municipality
Jätta	1	16	Stavanger
Type	Size	Gable	Exterior construction
Two-aisled	16 x 6-7	N/A	N/A
Orientation	Period	Uncalibrated BP	Reference
NW-SE	EBA I	3440 ± 55, 3215 ± 55	Hulth 1997

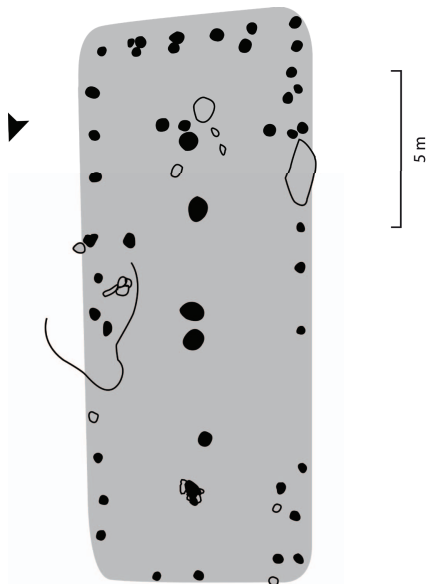
Farmstead	Structure no.	Cadastral/Holding no.	Municipality
Jätta	II	16	Stavanger
Type	Size	Gable	Exterior construction
Two-aisled	16 x 6	Straight	Bole walls
Orientation	Period	Uncalibrated BP	Reference
NW-SE	LVI II	3657 ± 36, 3448 ± 24	Hulth1997

Comments: Pottery sherds (S2250)

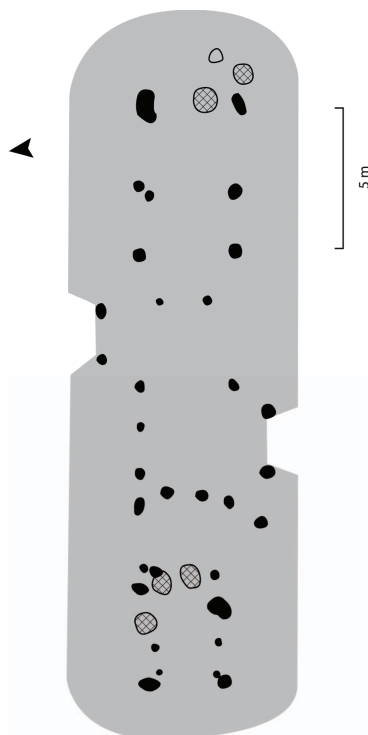
Farmstead	Structure no.	Cadastral/Holding no.	Municipality
Austbø	1	7	Stavanger
Type	Size	Gable	Exterior construction
Three-aisled	22 x 7	N/A	N/A
Orientation	Period	Uncalibrated BP	Reference
WNW-ESE	EBA I - EBA II	3320 ± 120, 3040 ± 110, 3320 ± 150	Juhl2001, Meling 2016

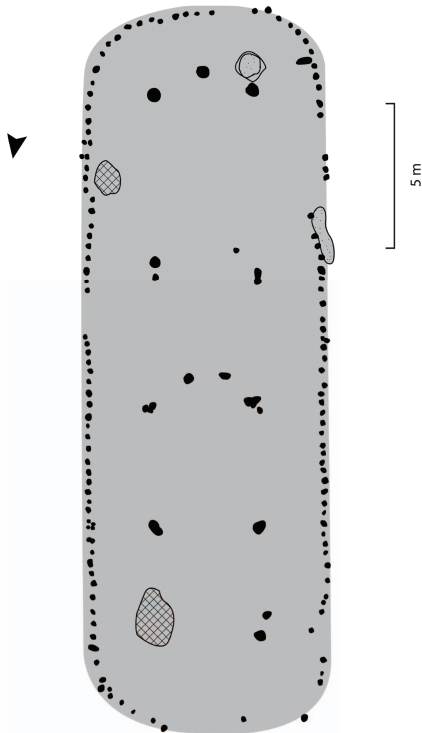
Farmstead	Structure no.	Cadastral/Holding no.	Municipality
Austbø	2	7	Stavanger
Type	Size	Gable	Exterior construction
Three-aisled	23 x 7.75	Curved	Wattle-and-Daub
Orientation	Period	Uncalibrated BP	Reference
N-S	EBA II	3155 ± 70, 3150 ± 80	Juhl 2001, Melting 2016

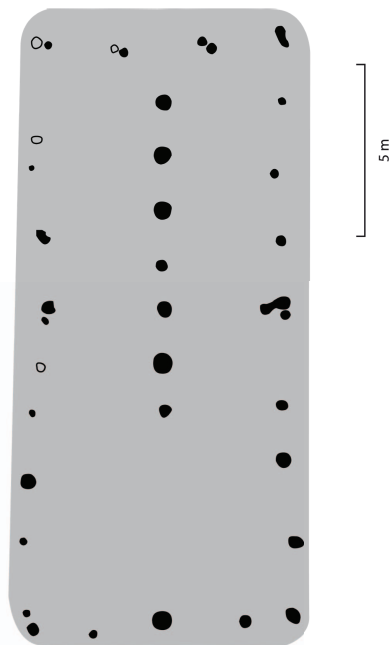
Farmstead	Structure no.	Cadastral/Holding no.	Municipality
Skeie	VI	5/10, 36	Stavanger
Type	Size	Gable	Exterior construction
Two-aisled	16,8 x 6,7-7,8	Straight	Wattle-and-Daub or Bole
Orientation	Period	Uncalibrated BP	Reference
N-S	LN - EBA	No radiometric dates	Tsigaridas 1998, Soltveit <i>et al.</i> 2007, Meling 2016

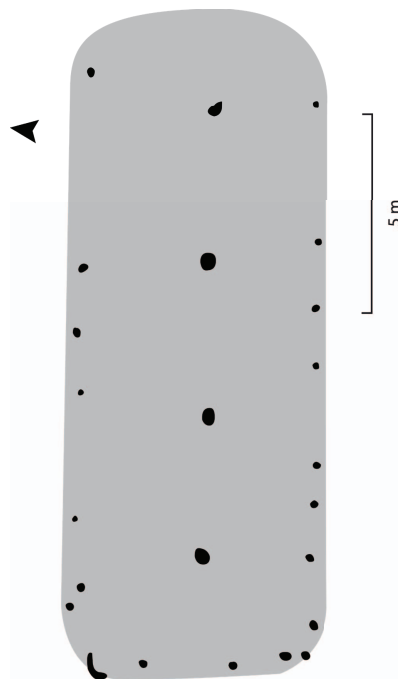
Farmstead	Structure no.	Cadastral/Holding no.	Municipality
Skeie	XXI	5/10, 36	Stavanger
Type	Size	Gable	Exterior construction
Two-aisled	14,6 x 5,8	Straight	Wattle-and-Daub
Orientation	Period	Uncalibrated BP	Reference
W-E	LN - EBA	No radiometric dates	Skare 1998, Soltveit <i>et al.</i> 2007, Meling 2016

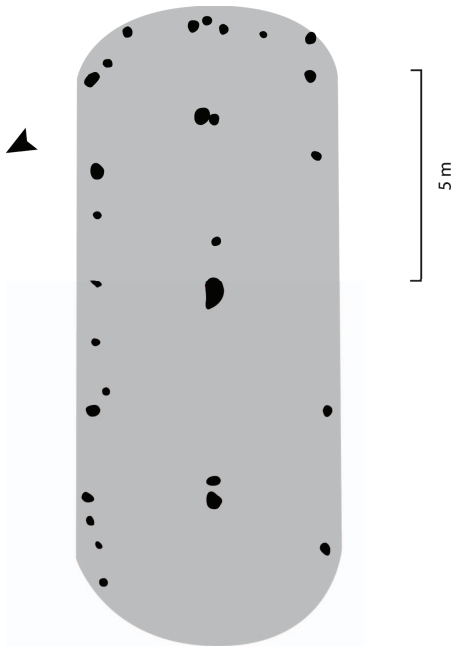
Farmstead	Structure no.	Cadastral/Holding no.	Municipality
Skeie	XXIV	5/10, 36	Stavanger
Type	Size	Gable	Exterior construction
Two-aisled	12,5 x 5-5,5	Straight?	Wattle-and-Daub
Orientation	Period	Uncalibrated BP	Reference
NW-SE	LN II - EBA I	3415 ± 60, 3410 ± 55	Skaare 1998, Soltveit <i>et al.</i> 2007, Mølling 2016

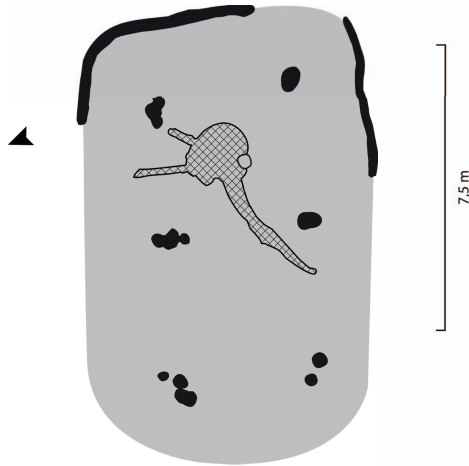
Farmstead	Structure no.	Cadastral/Holding no.	Municipality
Lunde	I	4/1, 13	Stavanger
Type	Size	Gable	Exterior construction
Three-aisled	12+ x 7	N/A	Planked-built/Trench
Orientation	Period	Uncalibrated BP	Reference
W-E	EBA I - EBA II	3190 ± 30, 3250 ± 30	Pedersen 2013

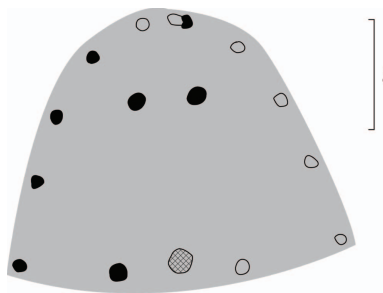
Farmstead	Structure no.	Cadastral/Holding no.	Municipality
Lebrekk	II	31/1	Strand
Type	Size	Gable	Exterior construction
Hut	N/A	N/A	N/A
Orientation	Period	Uncalibrated BP	Reference
N/A	EBA II	N/A	Løken 1987, Hovre 2010

Comments: An a-typical hut (a trapezoid layout). Charred cereal was uncovered in one of the postholes. Finds adjacent to the hut included flint debris, pottery sherds, a saddle quern, strike-a-light, and a cooking-pit. The house has been radiocarbon dated but is only referred to as c. 3400 years old (Løken 1987), i.e. EBA II.

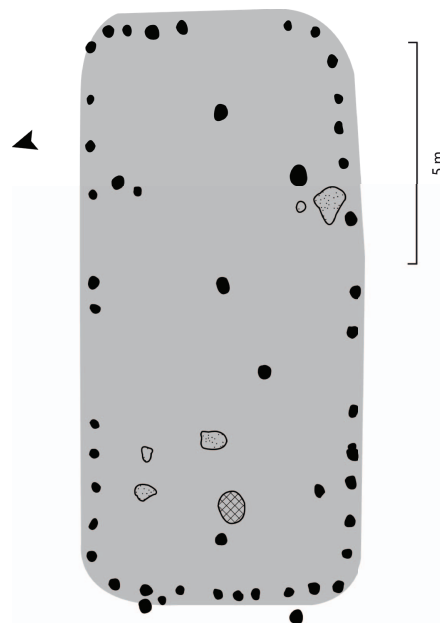
Farmstead	Structure no.	Cadastral/Holding no.	Municipality
Østebø (Taligje)	I	43/1	Finøy
Type	Size	Gable	Exterior construction
Two-aisled	13 x 6.5-6.8	Straight	Wattle-and-Daub
Orientation	Period	Uncalibrated BP	Reference
W-E	EBA I	3190 ± 70, 3280 ± 65, 3450 ± 60, 3380 ± 60, 3330 ± 60, 3205 ± 65	Hemclorff 1993, Hovre 2010

Comments: The house appears to have a partition. Four clay loom weights were uncovered in one of the wall posts.

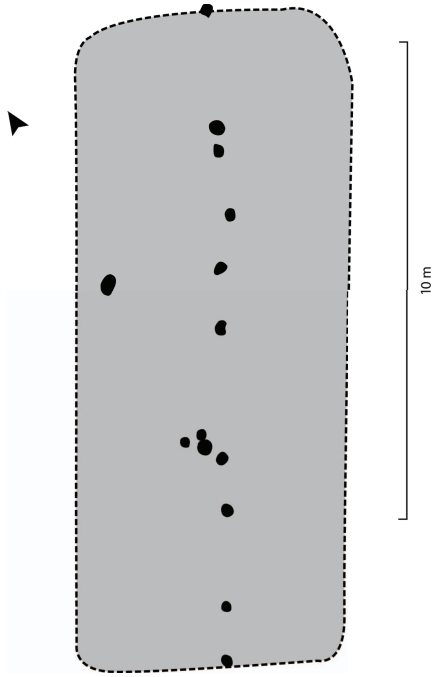
Farmstead	Structure no.	Cadastral/Holding no.	Municipality
Sørbo	N/A	12	Remesøy
Type	Size	Gable	Exterior construction
Two-aisled	13,5 x 4,5-5,0	N/A	N/A
Orientation	Period	Uncalibrated BP	Reference
SSW-NNE	LN II - EBA I	3395 ± 70, 3385 ± 60	Solvætt <i>et al.</i> 2007
