Data Set 1

House Structures

Note: Every house structure has been redrawn by the author from the original reports.

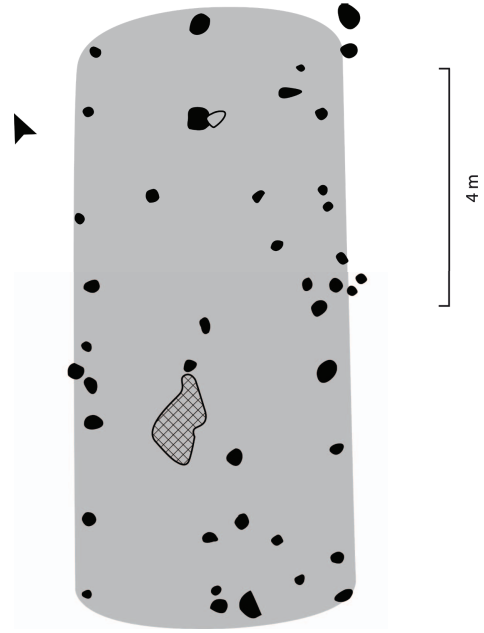
Farmstead	Structure no.	Cadastral/Holding no.	Municipality
Voll	N/A	4/2	Remesøy
Type	Size	Gable	Exterior construction
Two-aisled	10 x 3,9-4,2	N/A	Bole walls
Orientation	Period	Uncalibrated BP	Reference
SSW-NNE	LN I - LN II	3665 ± 65, 3560 ± 55, 3610 ± 65	Solvætt <i>et al.</i> 2007

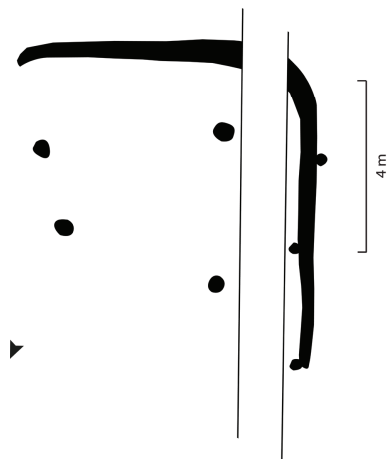
Farmstead	Structure no.	Cadastral/Holding no.	Municipality
Kvitanoill	8	198	Kvinnerød
Type	Size	Gable	Exterior construction
Three-aisled	7 + x7	Straight	Planked-built/Trench
Orientation	Period	Uncalibrated BP	Reference
NW-SE	EBA II - III	3110 ± 40	Engedal et al 2006

Comments: A trench around part of the house. Asbestos tempered pottery sherds and flint arrowheads were uncovered.

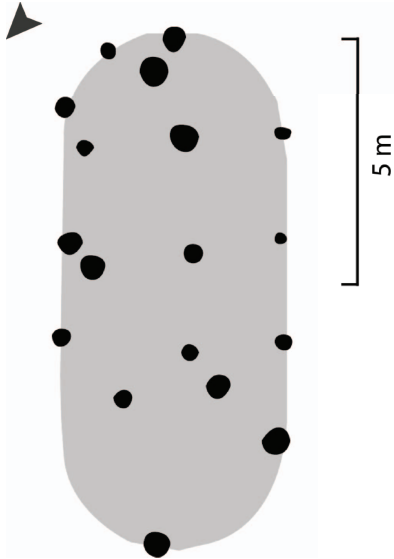
Farmstead	Structure no.	Cadastral/Holding no.	Municipality
Skåla	T	82	Kvinnherad
Type	Size	Gable	Exterior construction
Two-aisled	11 x 4,5	Curved	Bole-walls
Orientation	Period	Uncalibrated BP	Reference
NW - SE	LNI	3730 ± 40, 3600 ± 60	Olsen 2013

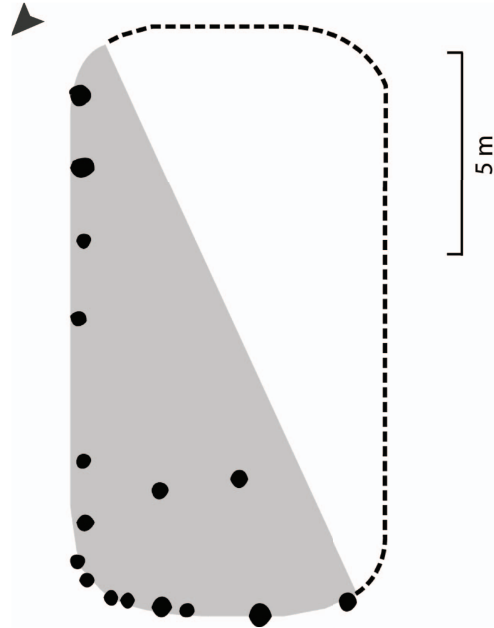
Farmstead	Structure no.	Cadastral/Holding no.	Municipality
Skåla	A	82	Kvinnherad
Type	Size	Gable	Exterior construction
Two-aisled	14,4 x 7,6	Curved?	Wattle-and-Daub?
Orientation	Period	Uncalibrated BP	Reference
NW-SE	LNI - II	3510 ± 40, 3620 ± 40	Olsen 2013

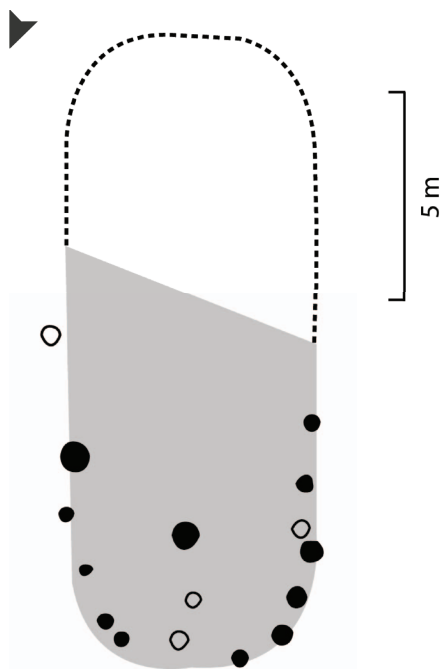
Farmstead	Structure no.	Cadastral/Holding no.	Municipality
Skåla	S	82	Kvinnherad
Type	Size	Gable	Exterior construction
Two-aisled	8,8+ x 5,5	Curved	Bole-walls
Orientation	Period	Uncalibrated BP	Reference
NNW-SSE	LN II	3490 ±40, 3470 ±40	Olsen 2013

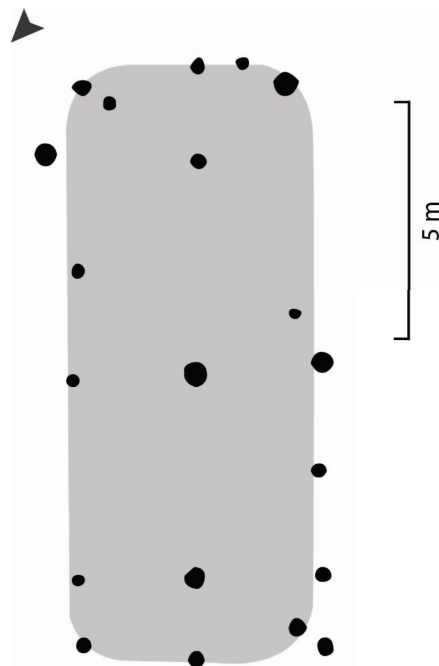
Farmstead	Structure no.	Cadastral/Holding no.	Municipality
Skåla	F	82	Kvinnherad
Type	Size	Gable	Exterior construction
Two-aisled	12,7 x 5,3	Straight	Bole-walls
Orientation	Period	Uncalibrated BP	Reference
NW-SE	LN II	3580 ±40, 3390 ±40	Olsen 2013

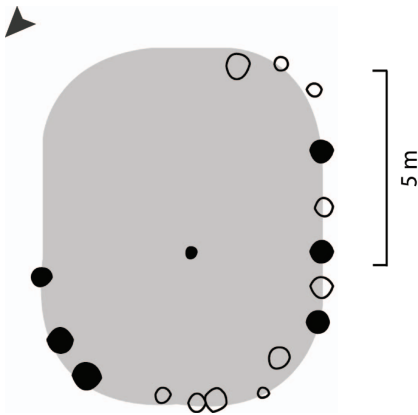
Farmstead	Structure no.	Cadastral/Holding no.	Municipality
Skåla	X	82	Kvinnherad
Type	Size	Gable	Exterior construction
Two-aisled/hut	8 x 8	Curved	Wattle-and-Daub?
Orientation	Period	Uncalibrated BP	Reference
NNW-SE	LN II - EBA I	3450 ± 40; 3460 ± 40	Olsen 2013

Comments: Contained a hearth/cooking pit.

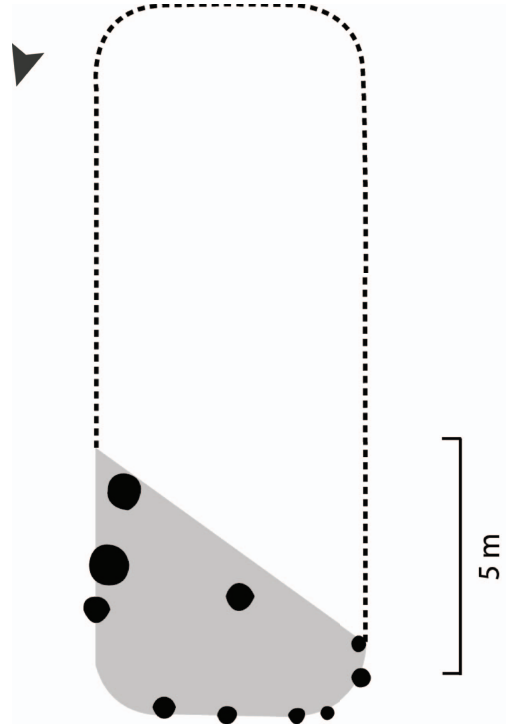
Farmstead	Structure no.	Cadastral/Holding no.	Municipality
Skåla	U	82	Kvinnherad
Type	Size	Gable	Exterior construction
Two-aisled	3.3+ x 5.4	Straight	N/A
Orientation	Period	Uncalibrated BP	Reference
NNW-SSE	LN II - EBA I	3390 ± 80	Olsen 2013

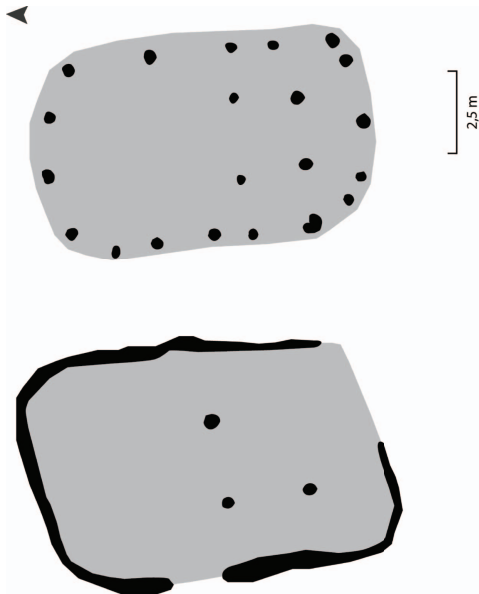
Farmstead	Structure no.	Cadastral/Holding no.	Municipality
Fremre Øygarden	A	49	Lærdal
Type	Size	Gable	Exterior construction
Three-aisled	10-11 m long	Curved	Planked-built/Trench and Bole?
Orientation	Period	Uncalibrated BP	Reference
NW-SE	LN II - EBA II	3265 ± 105	Dinhoff 2007

Comments: The house seems to have to phases; A1 has a trench around it while A2 have postholes.

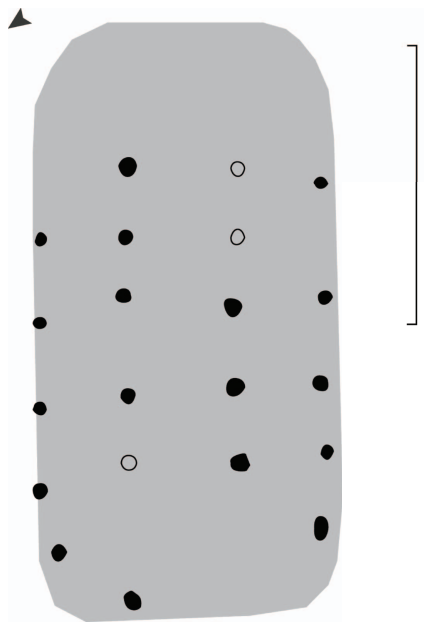
Farmstead	Structure no.	Cadastral/Holding no.	Municipality
Fremre Øygarden	C	49	Lærdal
Type	Size	Gable	Exterior construction
Three-aisled	12 m long	Curved	Bole-walls
Orientation	Period	Uncalibrated BP	Reference
NW-SE	EBA I - EBA III	3410 ± 40 BP	Dimnhoff 2007

Comments: This house has two radiocarbon dates; one between Early and Middle Neolithic, and one between Late Neolithic II and Early Bronze Age period I. These are interpreted in the original report as contaminations, and a typological dating is instead proposed to Early Bronze Age periods II and III. The second radiocarbon date 3410 ± 40 BP is in this authors opinion still a tenable date considering similar early dates in other regions.

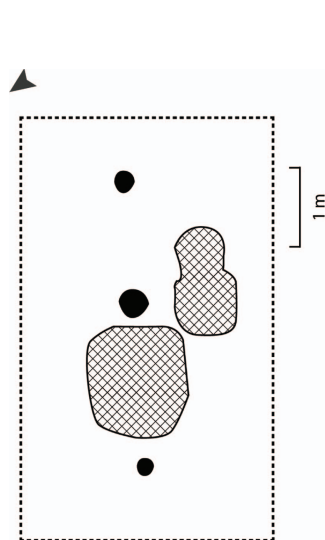
Farmstead	Structure no.	Cadastral/Holding no.	Municipality
Fremre Øygarden	D	49	Lærdal
Type	Size	Gable	Exterior construction
Hut	N/A	N/A	N/A
Orientation	Period	Uncalibrated BP	Reference
NW-SE	LN II - EBA II	3340 ± 90	Dimnhoff 2007

Comments: Possibly a workshop? Two hearths. Structure A214 is interpreted as an oven, possibly for metal production.

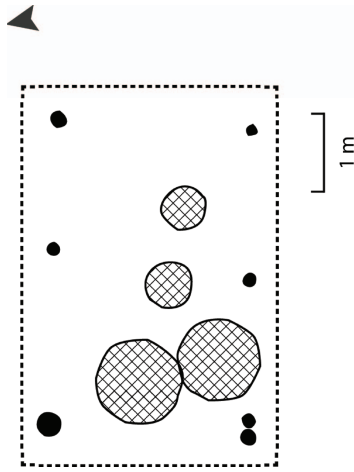
Farmstead	Structure no.	Cadastral/Holding no.	Municipality
Fremre Øygarden	F	49	Lærdal
Type	Size	Gable	Exterior construction
Hut	N/A	N/A	Bole-walls?
Orientation	Period	Uncalibrated BP	Reference
N/A	EBA III - LBA IV	3260 ± 40, 2940 ± 40	Dinnhoff 2007

Comments: Structures A227 and A229 are interpreted as ovens, possibly for metal production.

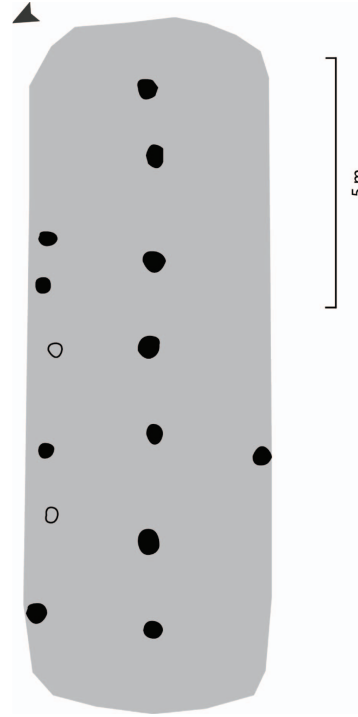
Farmstead	Structure no.	Cadastral/Holding no.	Municipality
Fremre Øygarden	G	49	Lærdal
Type	Size	Gable	Exterior construction
Two-aisled	14 x 4.5	N/A	Bole-walls
Orientation	Period	Uncalibrated BP	Reference
NW-SE	LN II-EBA I	N/A	Dinnhoff 2007

Comments: No radiometric dates, typologically dated.

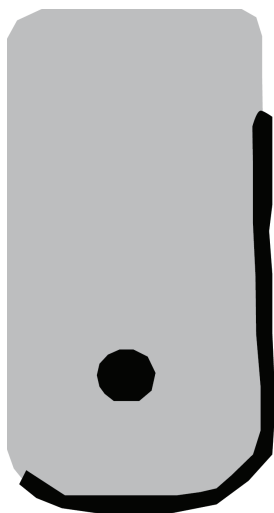
Farmstead	Structure no.	Cadastral/Holding no.	Municipality
Rutlin	I	22/4	Sogn dal
Type	Size	Gable	Exterior construction
Hut/two-aisled	N/A	Curved	Planked-built/Trench
Orientation	Period	Uncalibrated BP	Reference
	EBA III - LBA IV	2910 ±60	Dinnhoff and Hjelte 2003

Comments: Either a hut or possibly a fragmented two-aisled construction. Macro of barley from LN found at the site. Evidence of early agriculture was also found at the neighbouring farm Kvåle.

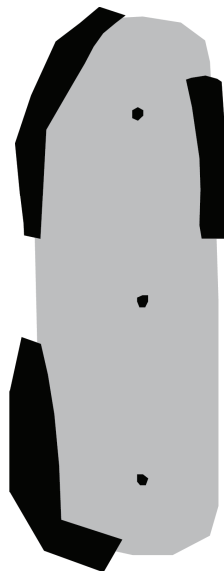
c. 12,6 m

Farmstead	Structure no.	Cadastral/Holding no.	Municipality
Kvåle	3	23	Sogn dal
Type	Size	Gable	Exterior construction
Two-aisled	12,6 x 4	Curved	Planked-built/Trench
Orientation	Period	Uncalibrated BP	Reference
N/A	LN I	3870 ±60	Olsen 2013

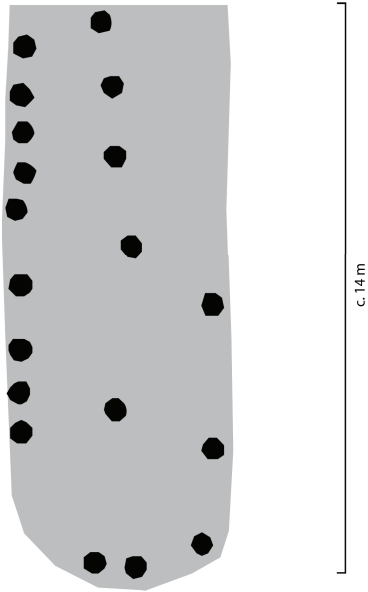
Farmstead	Structure no.	Cadastral/Holding no.	Municipality
Kvåle	4	23	Sogn dal
Type	Size	Gable	Exterior construction
Two-aisled	14 x 4,8	Curved	Wattle-and-Daub?
Orientation	Period	Uncalibrated BP	Reference
N/A	LN I	3770 ±40	Olsen 2013

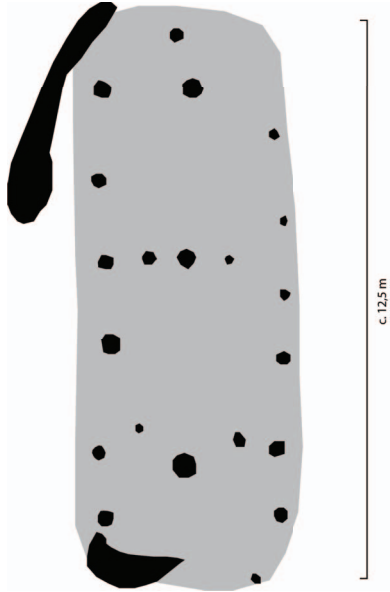
Farmstead	Structure no.	Cadastral/Holding no.	Municipality
Gurvin	N/A	23,24	Sogn dal
Type	Size	Gable	Exterior construction
Two-aisled	12,5 x 4,3	N/A	Bole-walls with trench
Orientation	Period	Uncalibrated BP	Reference
N/A	LN I - LN III	3550 ±40	Olsen 2013

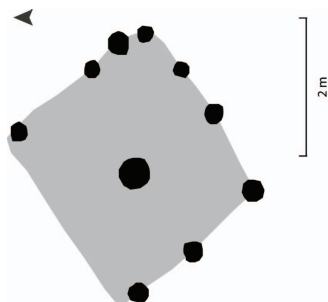
Farmstead	Structure no.	Cadastral/Holding no.	Municipality
Henjum	V	17/76	Leikanger
Type	Size	Gable	Exterior construction
Hut	3 x 2.8	Straight	Bole-walls or Wattle-and-Daub
Orientation	Period	Uncalibrated BP	Reference
SW-NE	LNI - LNII	3600 ± 30	Dinnhoff 2004, 2016

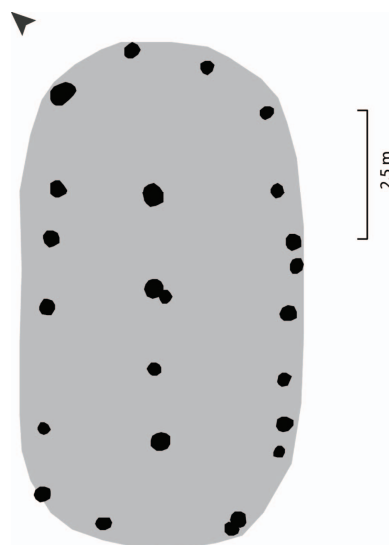
Farmstead	Structure no.	Cadastral/Holding no.	Municipality
Henjum	VI	17/76	Leikanger
Type	Size	Gable	Exterior construction
Two-aisled	9.8 x 5.5	Curved	Bole-walls
Orientation	Period	Uncalibrated BP	Reference
SW-NE	EBA I	3330 ± 30	Dinnhoff 2004, 2016

Comments: The report mentions that the radiocarbon date is possibly polluted by cultivation layer.

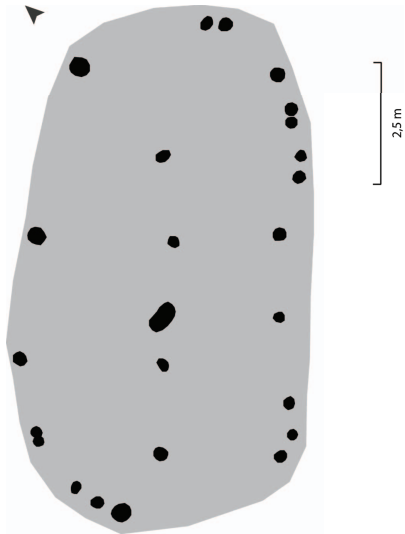
Farmstead	Structure no.	Cadastral/Holding no.	Municipality
Henjum	VII	17/76	Leikanger
Type	Size	Gable	Exterior construction
Two-aisled	10.4 x 6	Curved	Wattle-and-Daub?
Orientation	Period	Uncalibrated BP	Reference
SW-NE	EBA II - EBA III	3330 ± 30	Dinnhoff 2004, 2016

Comments: Clay was uncovered in one posthole (from wattle-and-daub technique?). In and around the house there were uncovered burnt bone, flint arrowhead, flint scraper, asbestos-tempered pottery sherds, and a dagger was found in the topsoil: B16079.

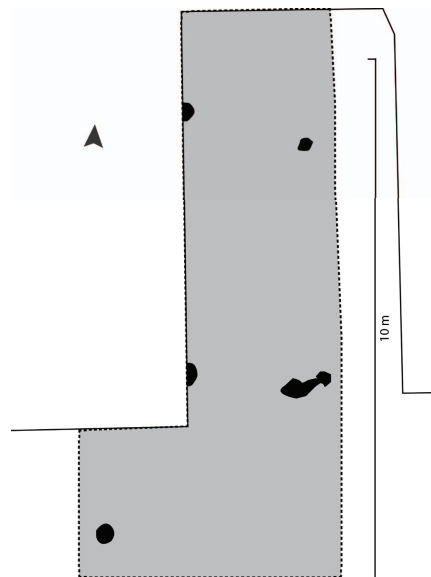
Farmstead	Structure no.	Cadastral/Holding no.	Municipality
Noretik	N/A	26/3	Høyanger
Type	Size	Gable	Exterior construction
Two-aisled	N/A	N/A	N/A
Orientation	Period	Uncalibrated BP	Reference
N-S	LN I	3740 ± 70	Telesfær 2007

Comments: Possibly the remains of a two-aisled construction.

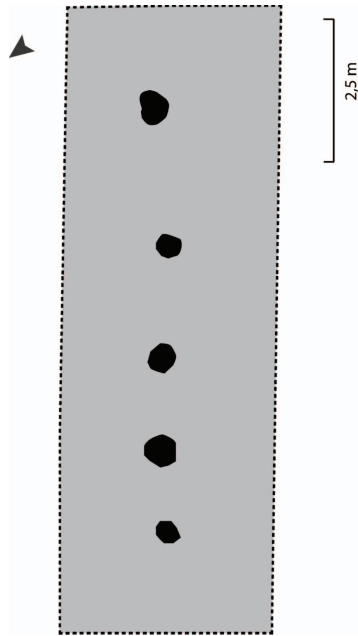
Farmstead	Structure no.	Cadastral/Holding no.	Municipality
Homes	XVI	20/7	Førde
Type	Size	Gable	Exterior construction
Two-aisled	8+ (min. 10 x 5)	N/A	N/A
Orientation	Period	Uncalibrated BP	Reference
NW-SE	EBA II - LBA V	2970 ± 150	Dimnhoff 1996

Comments: Unclear whether or not this house structure can be dated to the Early Bronze.

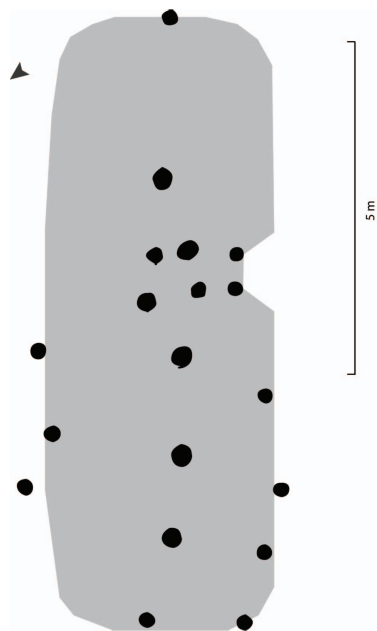
Farmstead	Structure no.	Cadastral/Holding no.	Municipality
Sæla	N/A	96	Naustdal
Type	Size	Gable	Exterior construction
Two-aisled	c. 14-15 x 3,5	Straight?	Bole-walls
Orientation	Period	Uncalibrated BP	Reference
NW-SE	LN-EBA-PRIA	N/A	Olsen and Tellefsen 2008

Comments: One radiocarbon date to the Pre-Roman Iron Age and second to the Early Iron Age, but as mentioned in the report, modern disturbances, including glass, make these dates questionable. Based on typology a Late Neolithic-Early Bronze Age date seems just as tenable. The site also include cultivation layers to LN-EBA.

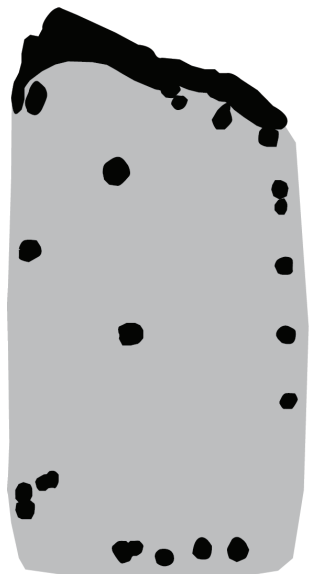
Farmstead	Structure no.	Cadastral/Holding no.	Municipality
Indre-Henden	N/A	147	Eid
Type	Size	Gable	Exterior construction
Two-aisled	7 x 4	Straight	Bole with trench
Orientation	Period	Uncalibrated BP	Reference
N/A	LN I - LN II	3540 ± 70	Olsen 2004

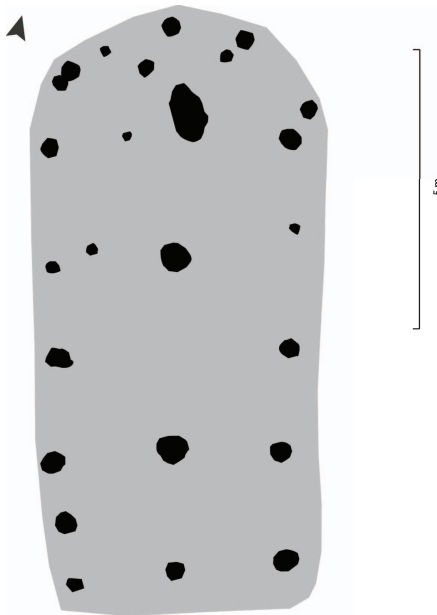
Farmstead	Structure no.	Cadastral/Holding no.	Municipality
Hjelle	N/A	52/6	Eid
Type	Size	Gable	Exterior construction
Two-aisled	10.5 x 4.4	Curved	Bole-walls
Orientation	Period	Uncalibrated BP	Reference
NW-SSE	LN II - EB A I	3650 ± 90, 3320 ± 60, 3320 ± 70, 3010 ± 70, 3330 ± 60, 3560 ± 70, 3490 ± 40, 3360 ± 40	Stimming 2005

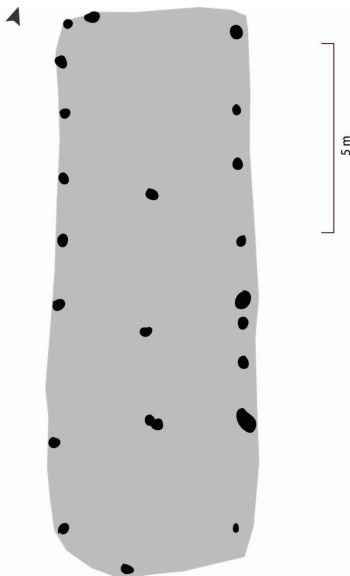
Farmstead	Structure no.	Cadastral/Holding no.	Municipality
Fiskå	IV	11	Vanylven
Type	Size	Gable	Exterior construction
Two-aisled	14.5 x 5.1	Curved and Straight	Bole-walls
Orientation	Period	Uncalibrated BP	Reference
N-S	LN - EBA - EIA	N/A	Dinhoff 1998

Comments: Tentatively dated to Late Neolithic-Early Bronze Age based on typology.

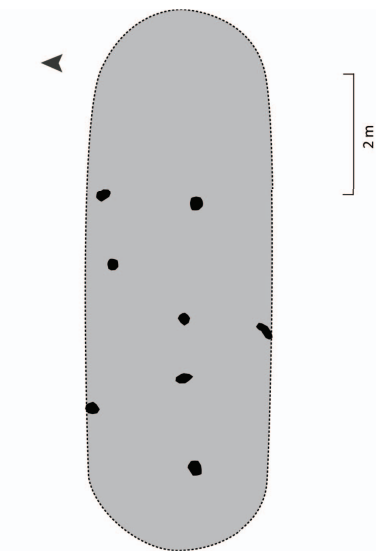
Farmstead	Structure no.	Cadastral/Holding no.	Municipality
Håvoll	I	5	Ørsta
Type	Size	Gable	Exterior construction
Two-aisled	N/A	N/A	Bole-walls
Orientation	Period	Uncalibrated BP	Reference
E-W	LN I - LN II	3610 ± 60, 3580 ± 110	Berge 2005

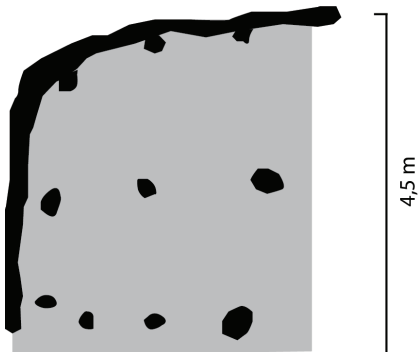
Farmstead	Structure no.	Cadastral/Holding no.	Municipality
Yre Hauge	N/A	12	Sande
Type	Size	Gable	Exterior construction
Hut	4.5 x 4.5	Straight	Planked-built/Trench
Orientation	Period	Uncalibrated BP	Reference
N/A	MNB- LN1	3970 ± 140	Olsen 2013

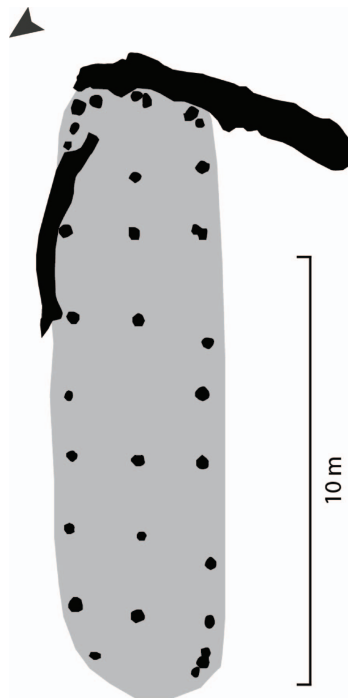
Farmstead	Structure no.	Cadastral/Holding no.	Municipality
Stokkset	1	3	Sande
Type	Size	Gable	Exterior construction
Two-aisled	14 x 3.5	Curved	Planked-built/Trench
Orientation	Period	Uncalibrated BP	Reference
NW-SE	LN	N/A	Johnson and Prescott 1993

Comments: Asbestos tempered pottery fragments and animal bones were uncovered at the site, as well as furrow traces.

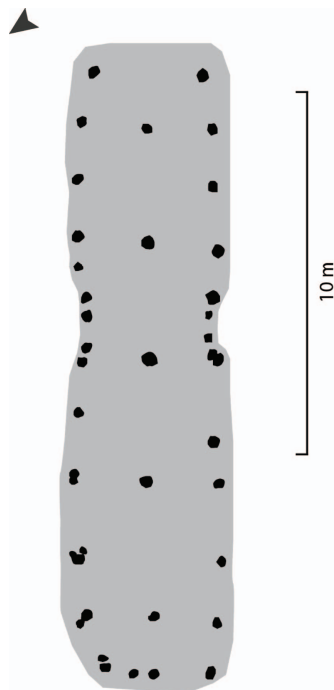
Farmstead	Structure no.	Cadastral/Holding no.	Municipality
Stokkset	2	3	Sande
Type	Size	Gable	Exterior construction
Two-aisled	18 x 4	Straight	Planked-built/Trench/bolt-walls?
Orientation	Period	Uncalibrated BP	Reference
NW-SE	LN	N/A	Johnson and Prescott 1993

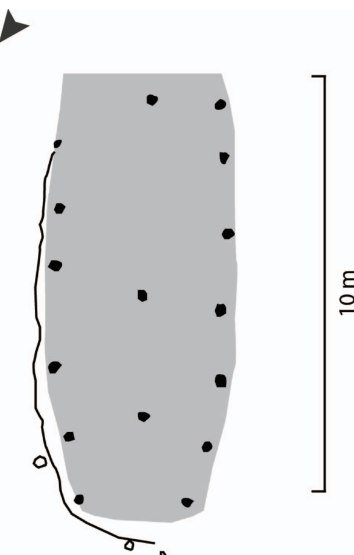
Farmstead	Structure no.	Cadastral/Holding no.	Municipality
Stokkset	3	3	Sande
Type	Size	Gable	Exterior construction
Two-aisled	N/A	N/A	Planked-built/Trench
Orientation	Period	Uncalibrated BP	Reference
NW-SE	LN	N/A	Johnson and Prescott 1993

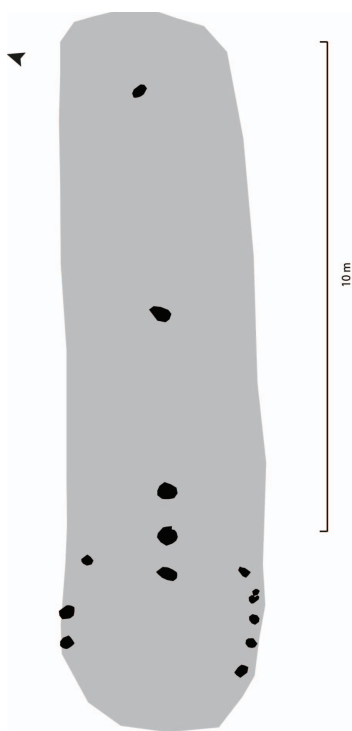
Farmstead	Structure no.	Cadastral/Holding no.	Municipality
Skeide and Osnes	1	N/A	Ulstein
Type	Size	Gable	Exterior construction
Two-aisled	N/A	Curved?	N/A
Orientation	Period	Uncalibrated BP	Reference
W-E	LN II - EBA I	3470 ± 50	Johannessen 2004, Halvorsen and Hjelte 2004

Comments: Uncertain if this ground plan represents a two-aisled construction. One posthole contained macro of barley radiocarbon dated to LN II - EBA I.

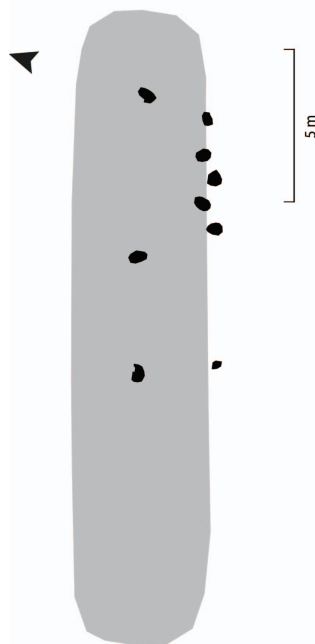
Farmstead	Structure no.	Cadastral/Holding no.	Municipality
Vinje	I	128/7	Stordal
Type	Size	Gable	Exterior construction
Two-aisled	15.5 x 4.6	N/A	Wattle-and-Daub?
Orientation	Period	Uncalibrated BP	Reference
SW-NE	LN II	3610 ± 30, 3600 ± 30, 3560 ± 30, 3390 ± 30, 3380 ± 30	Østrebo 2012

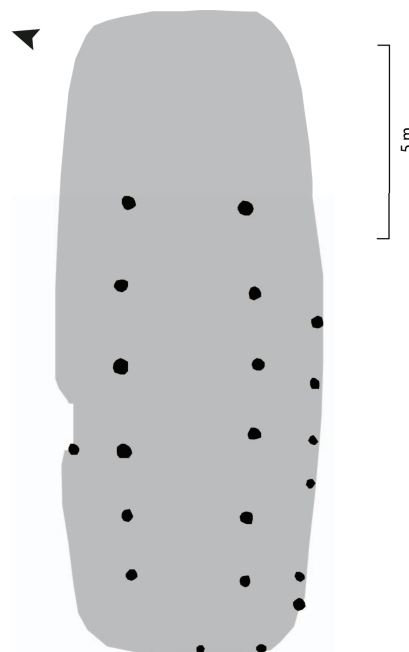
Farmstead	Structure no.	Cadastral/Holding no.	Municipality
Melsethøien	II	128	Stordal
Type	Size	Gable	Exterior construction
Three-aisled	16.4 x 5.6	Curved	Bole-walls
Orientation	Period	Uncalibrated BP	Reference
SW-NE	EBA II - III	3010 ± 60, 3090 ± 70	Dinnhoff 2017

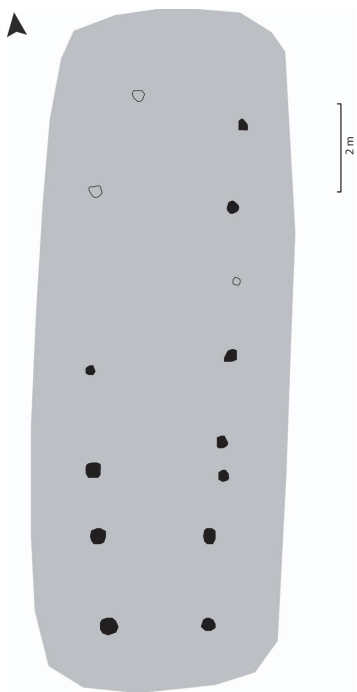
Farmstead	Structure no.	Cadastral/Holding no.	Municipality
Sjoholt	Ia	97/6	Ørskog
Type	Size	Gable	Exterior construction
Three-aisled	15-16 x 5-6	Curved	N/A
Orientation	Period	Uncalibrated BP	Reference
N-S	EBA III-IV	2870 ± 70, 2870 ± 40	Johannessen 2002

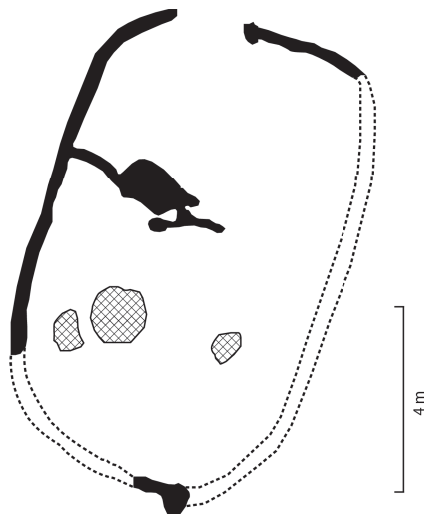
Farmstead	Structure no.	Cadastral/Holding no.	Municipality
Sjoholt	III	97/6	Ørskog
Type	Size	Gable	Exterior construction
Hut	10.2 x 6.6	N/A	Planked-built/Trench
Orientation	Period	Uncalibrated BP	Reference
N/A	EBA II - EBA III	3100 ± 60	Johannessen 2002

Comments: A hut-like structure with a partial partition and hearths.

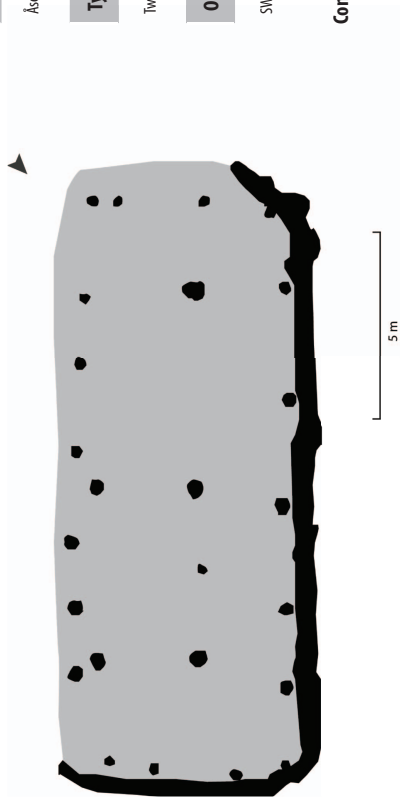
Farmstead	Structure no.	Cadastral/Holding no.	Municipality
Åse	N/A	50/1	Ålesund
Type	Size	Gable	Exterior construction
Two-abled	13 x 5.5	Straight	Planked-built/Trench
Orientation	Period	Uncalibrated BP	Reference
SW-NE	LN I - LNIII	3540 ± 60, 3560 ± 70	Olsen 2006

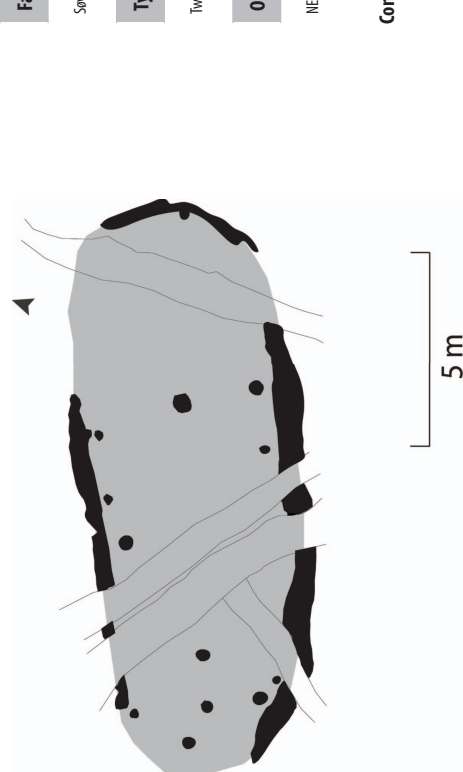
Farmstead	Structure no.	Cadastral/Holding no.	Municipality
Søvik	1	175	Haram
Type	Size	Gable	Exterior construction
Two-abled	14.5 x 4.5	Curved	Planked-built/Trench
Orientation	Period	Uncalibrated BP	Reference
NE-SW	LN I - LNIII	3770 ± 40, 3610 ± 40, 3480 ± 40, 3440 ± 40	Årsveit and Zinsli 2011

Comments: Cairn nearby. One cairn was radiocarbon-dated to the Early Bronze Age.

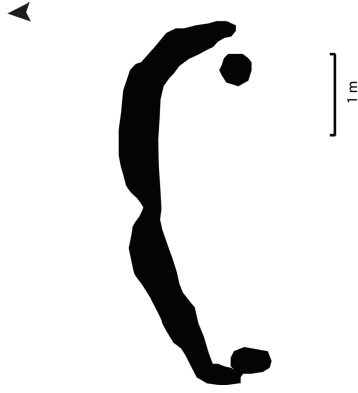
Farmstead	Structure no.	Cadastral/Holding no.	Municipality
Søvik	2	175	Haram
Type	Size	Gable	Exterior construction
Two-abled	N/A	Curved	Planked-built/Trench
Orientation	Period	Uncalibrated BP	Reference
N-S	LN II	3520 ± 40	Årveit and Zinsli 2011

Comments: Slate and flint were uncovered. Only the an outer curved gable wall (ditch) and two postholes remain.

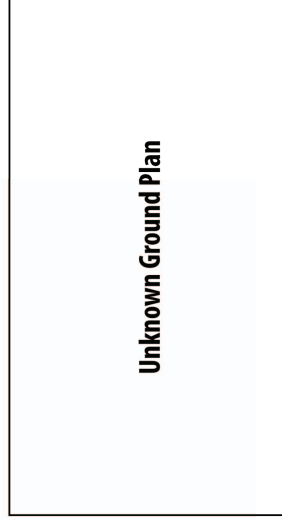
Farmstead	Structure no.	Cadastral/Holding no.	Municipality
Fjertoft	1	3	Haram
Type	Size	Gable	Exterior construction
N/A	N/A	N/A	N/A
Orientation	Period	Uncalibrated BP	Reference
N/A	LN-IA	N/A	Agones 1986

Comments: Highly uncertain, but the site contained numerous postholes in layers with flint, asbestos tempered pottery sherds, and pumice rock.

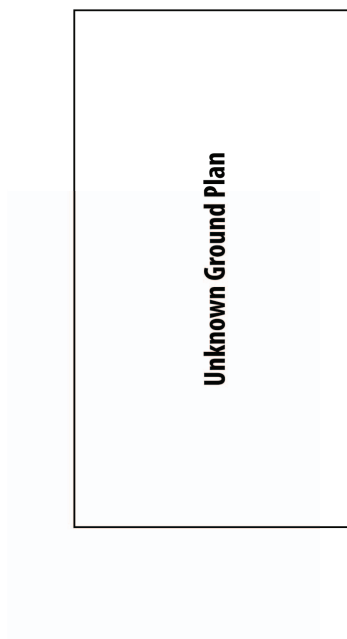
Farmstead	Structure no.	Cadastral/Holding no.	Municipality
Fjærtøft	2	3	Haram
Type	Size	Gable	Exterior construction
N/A	N/A	N/A	N/A
Orientation	Period	Uncalibrated BP	Reference
N/A	LN-IA	N/A	Olsen 1979, Alsaker 1980

Comments: Five postholes that appear to be stratigraphical earlier than LBA layers. Hearth dated to EBA, and finds included a pressure-flaked arrowhead, asbestos tempered pottery sherds, and a saddle quern.

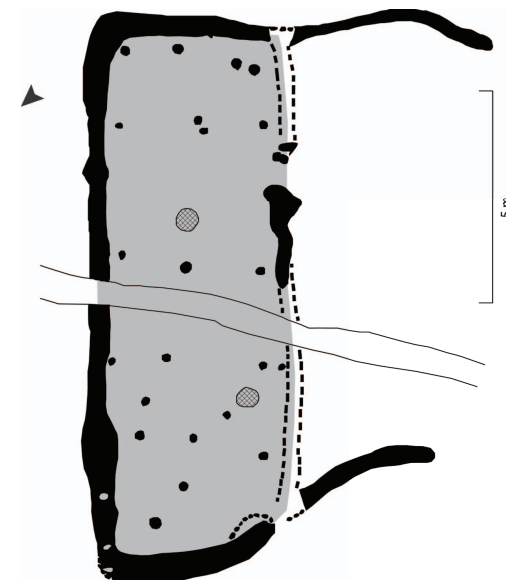
Farmstead	Structure no.	Cadastral/Holding no.	Municipality
Boen	1	48	Midsund
Type	Size	Gable	Exterior construction
N/A	13 x 4.5	Straight	Planked-built/Trench
Orientation	Period	Uncalibrated BP	Reference
NW-SE	BA	3360 ± 60, 2800 ± 70	Birgisdottir and Haug 1999

Comments: Atypical construction. Finds included two hearths and flint debris.

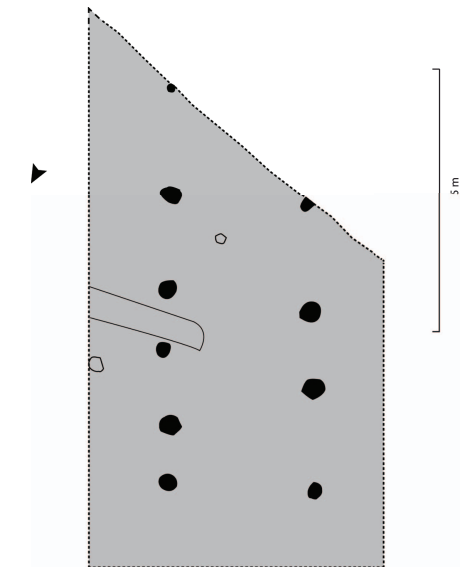
Farmstead	Structure no.	Cadastral/Holding no.	Municipality
Våge	N/A	185/1	Rauma
Type	Size	Gable	Exterior construction
Three-aisled?	N/A	N/A	N/A
Orientation	Period	Uncalibrated BP	Reference
NNW-SSE	LN II	3420 ± 30, 3490 ± 30	Lorentzen <i>et al.</i> 2015

Comments: Traces of what appears to be the remains of a three-aisled longhouse. Corresponding radiocarbon dates from each row substantiates this claim. If correct, this house is among the earliest three-aisled constructions in northwestern Scandinavia.

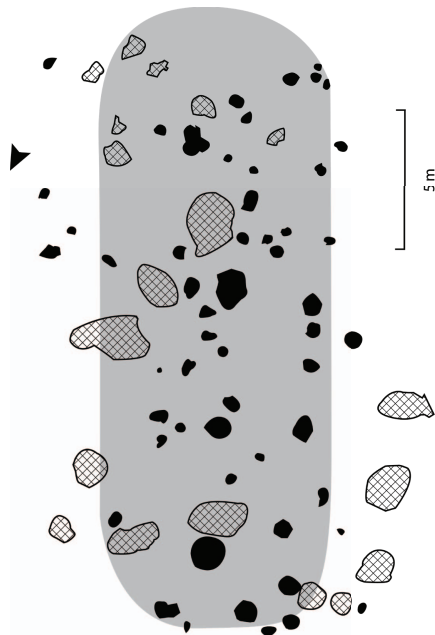
Farmstead	Structure no.	Cadastral/Holding no.	Municipality
Torhaug	II	N/A	Molde
Type	Size	Gable	Exterior construction
Two-aisled	c. 15 m long	N/A	N/A
Orientation	Period	Uncalibrated BP	Reference
N-S	EBA I	3450 ± 35, 3340 ± 30, 3305 ± 30	Haug 2011

Comments: Some deviating dates, but three structures correspond to EBA I. A hearth, flint debris, and a cooking pit with a similar date were uncovered nearby. There were reports of a lot of charcoal in the postholes - burnt down?

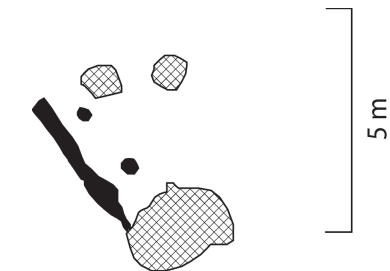
Farmstead	Structure no.	Cadastral/Holding no.	Municipality
Sporstad	III	9/26	Aukra
Type	Size	Gable	Exterior construction
Three-aisled	5 m wide	Curved?	Planked-built/Trench
Orientation	Period	Uncalibrated BP	Reference
N/A	EBA I - EBA III	3220 ± 100; 3095 ± 80	Melting 2008b

Comments: Possibly the remains of a three-aisled longhouse.

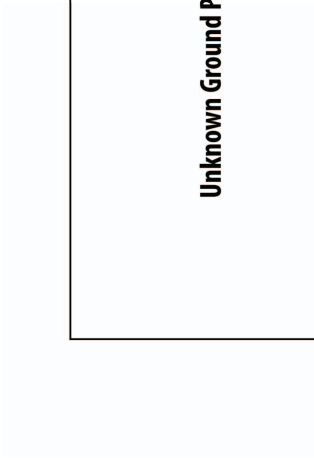
Farmstead	Structure no.	Cadastral/Holding no.	Municipality
Gavråksmoen	II	N/A	Meihus
Type	Size	Gable	Exterior construction
Three-aisled?	N/A	N/A	N/A
Orientation	Period	Uncalibrated BP	Reference
N/A	EBA III	1310 - 1130 BCE	Ronne 2005

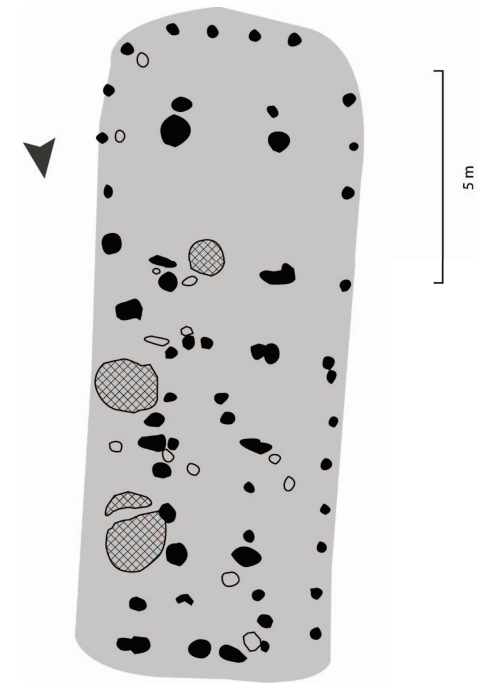
Farmstead	Structure no.	Cadastral/Holding no.	Municipality
Søberg	II	90/2	Meihus
Type	Size	Gable	Exterior construction
Three-aisled	N/A	Curved	Wattle-and-Daub
Orientation	Period	Uncalibrated BP	Reference
N-S	EBA II - LBA IV	2940 ± 110	Ronne 2005

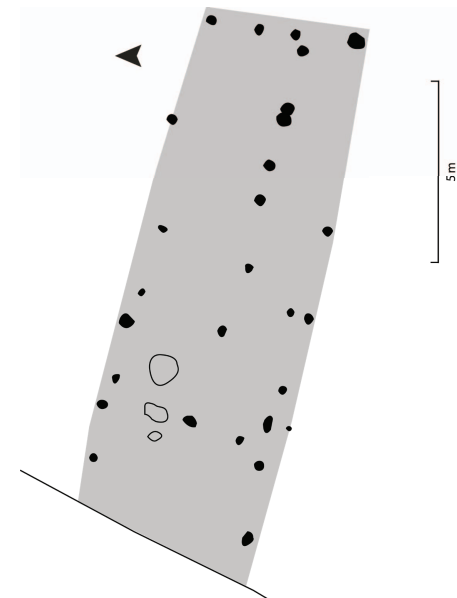
Farmstead	Structure no.	Cadastral/Holding no.	Municipality
Søberg	VII	90/2	Meihus
Type	Size	Gable	Exterior construction
Two-aisled	16m+ in length	Straight	N/A
Orientation	Period	Uncalibrated BP	Reference
NW-SE	LN-EBA I?	N/A	Ronne 2005

Comments: No radiometric dates.

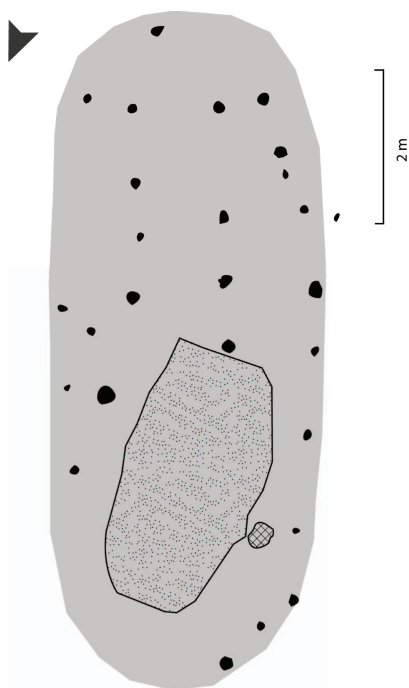
Farmstead	Structure no.	Cadastral/Holding no.	Municipality
Kvenild	S	313	Trondheim
Type	Size	Gable	Exterior construction
Three-aisled	15.5 x 5.5	Curved	Wattle-and-Daub?
Orientation	Period	Uncalibrated BP	Reference
N-S	EBA III - LBA IV	2980 ± 75	Grommesby 2005

Comments: Uncertain, as another radiocarbon date points to Pre-Roman Iron Age.

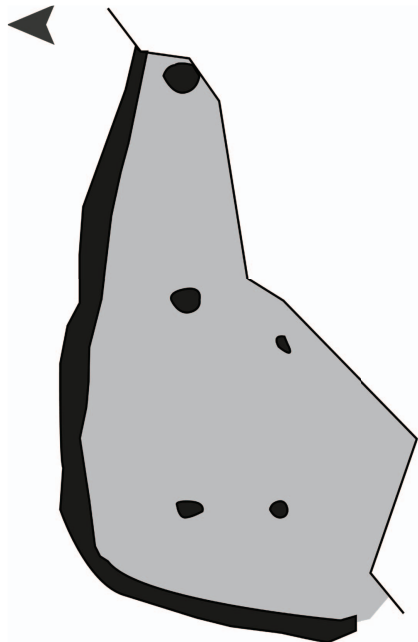
Farmstead	Structure no.	Cadastral/Holding no.	Municipality
Husby	101/2	I	Sjørdal
Type	Size	Gable	Exterior construction
Three-aisled	N/A	Straight	Planked-built/Trench
Orientation	Period	Uncalibrated BP	Reference
W-E	EBaII	3135 ± 30, 3170 ± 30, 3075 ± 40, 3175 ± 30	Rullestad 2010

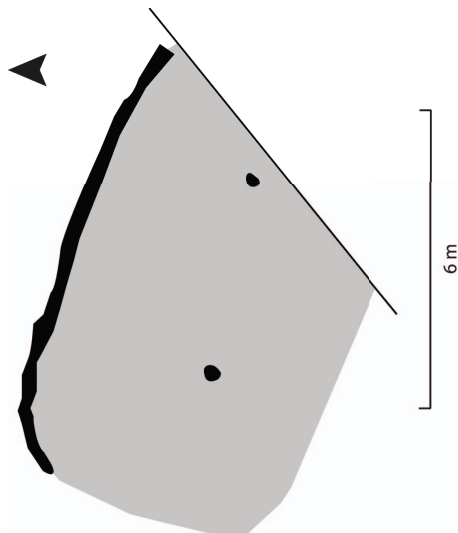
Farmstead	Structure no.	Cadastral/Holding no.	Municipality
Husby	101/2	II	Sjørdal
Type	Size	Gable	Exterior construction
Two-aisled	N/A	N/A	Planked-built/Trench
Orientation	Period	Uncalibrated BP	Reference
NW-SE	LN1-LNIII	3650 ± 35, 3570 ± 30	Rullestad 2010

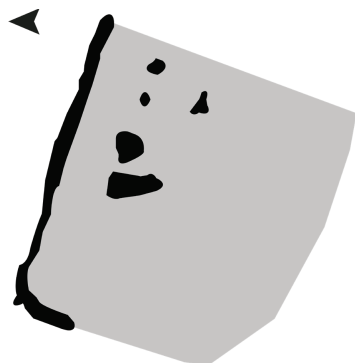
Farmstead	Structure no.	Cadastral/Holding no.	Municipality
Husby	101/2	III	Sjurdal
Type	Size	Gable	Exterior construction
Hut?	5 x 4	Straight	Planked-built/Trench
Orientation	Period	Uncalibrated BP	Reference
NW-SE	LN II	3165 ± 35, 3515 ± 35, 3665 ± 35	Rullestad 2010

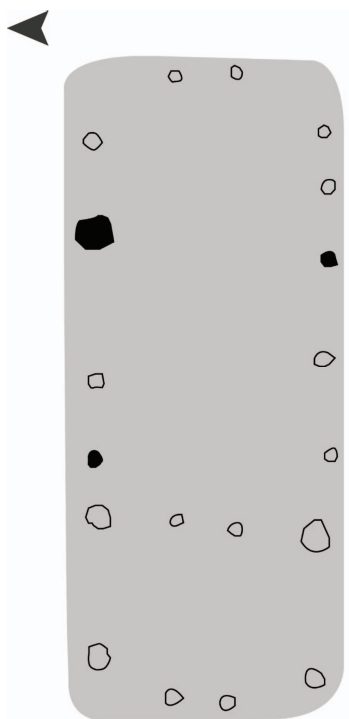
Farmstead	Structure no.	Cadastral/Holding no.	Municipality
Gjemble	I	4/1	Levanger
Type	Size	Gable	Exterior construction
N/A	N/A	Straight	Bole-walls
Orientation	Period	Uncalibrated BP	Reference
W-E	EBA I - EBA II	3450 ± 30, 3280 ± 30, 2990 ± 30	Hein-Petersen and Ysgaard 2015

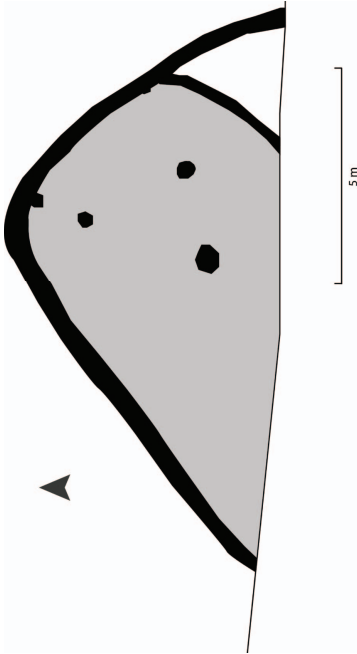
Farmstead	Structure no.	Cadastral/Holding no.	Municipality
Gjemble	II	4/1	Levanger
Type	Size	Gable	Exterior construction
N/A	N/A	Curved?	Planked-built/Trench
Orientation	Period	Uncalibrated BP	Reference
SW-NE	LN - EBA	N/A	Heen-Petersen and Ystgaard 2015

Comments: Stratigraphically earlier than house structure no. 1.
